Petersburg Borough

Harbor Facilities

Condition Assessment Report

Presented to:
Borough of Petersburg
November 24, 2015

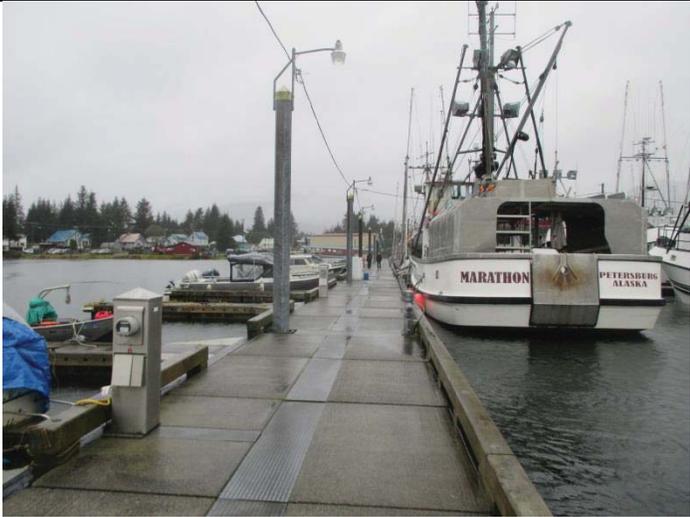
The headwalk float is in fair condition (Photo 5). The concrete deck is generally sound with few cracks or spalls. The float is generally sits level, except for at the ends where the gangways rest. The cantilevered finger floats (Photo 6) are used to moor small skiffs and pleasure vessels. These fingers are in good condition with most sitting level in the water, and with only minor damage from normal wear and tear to the rub boards and cleats. Some fingers have moss and other vegetation growing between the gap in the wailer and the concrete float. The head walk float is generally in better condition than the other floats because it is in a more protected location in the harbor, and it only accommodates smaller vessels.

5. Headwalk Float, typical condition

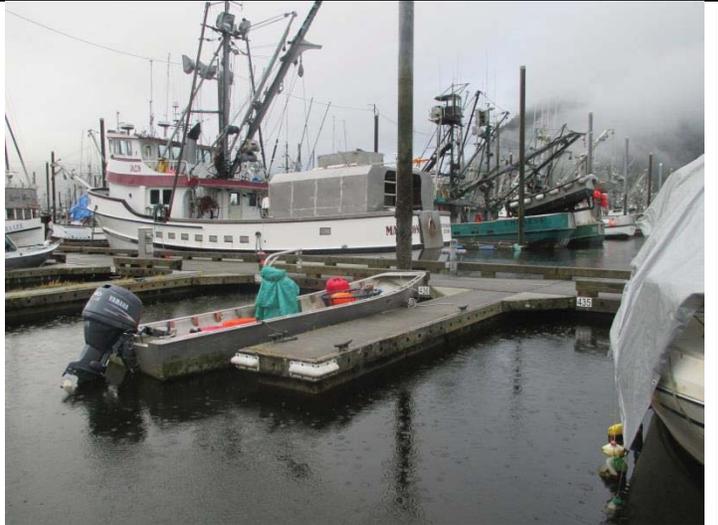
6. Typical skiff float at Headwalk float

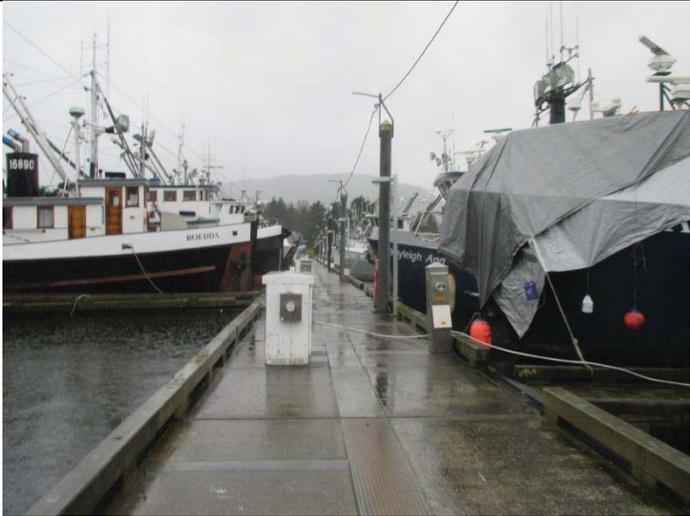
The main walk of Float D is in fair condition with minor to moderate damage typical (Photo 7). The deck is in good shape with occasional small spalls and cracks. Small lips were observed between some concrete modules, especially where heavy loads such as stepdown transformers are located. The lips between modules are indicative of wear between the thru-rods and wales. The utility chases tend to exacerbate the lips somewhat, where the steel edge could be bent by heavy loads or snowplowing equipment.

7. D Float typical condition

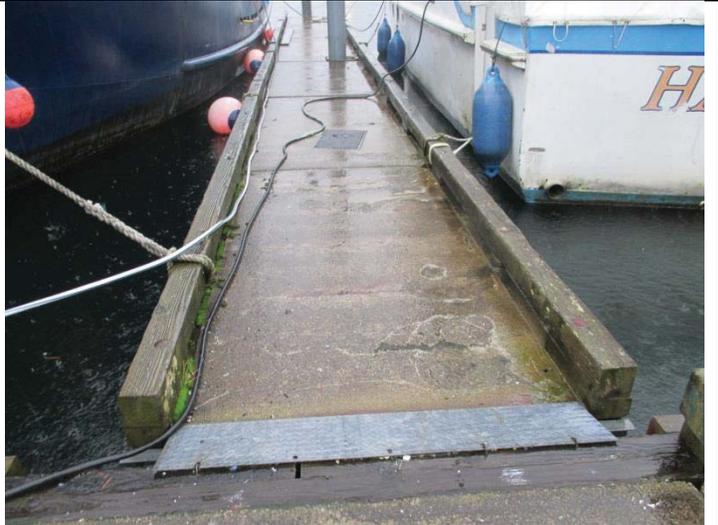
8. D float finger with cracked/spalled concrete and flotation loss.

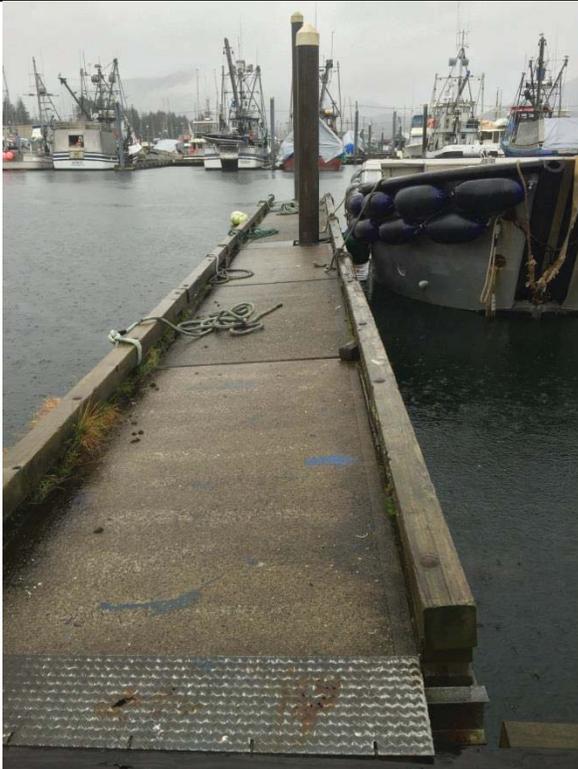
The fingers on Float D range from fair to poor condition. Many of the fingers sit with an East-West list of 2" or more (Photo 9, 10). Due to the listing, the rigid transition plates between the fingers and the main walk sit unevenly, creating a trip hazard. Many of the hinges show signs of stress due to general wear and tear, and accommodating the twist. The hinges are constructed using a rubber fender component, which allows them to remain relatively compliant to the twist. The concrete decks have periodic damage in the form of small spalls and cracks, as well as occasional large spalls exposing reinforcing and the flotation billets (Photo 8). Moss and marine growth occurs on the bullrails, which while generally sound, have increased wear and tear over the bullrails on the main walk this includes minor cracks, splits, and wear from line handling. The blocking for the bullrails were also occasionally damaged or twisted out of alignment with the bullrail. Generally, more exposed fingers to the East and the North are more heavily damaged due to the size of the vessels moored and their more exposed location.

9. Twisted finger float on D float, note trip hazard at transition plate

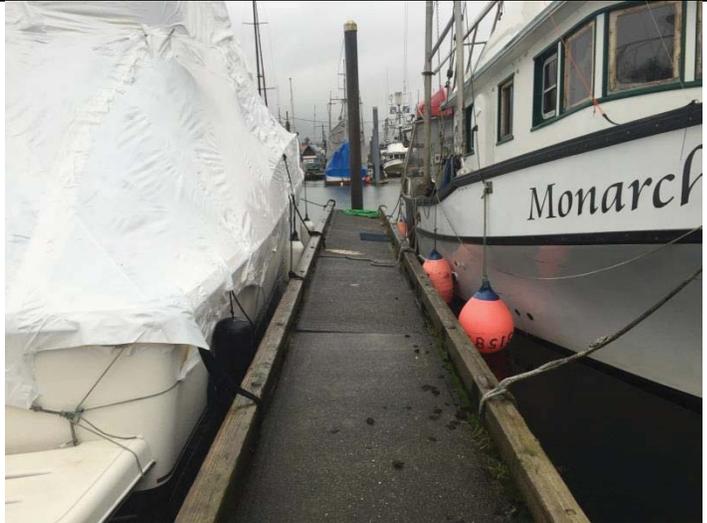
10. Twisted finger float on D float, note spall repair and displacement at concrete module joints.

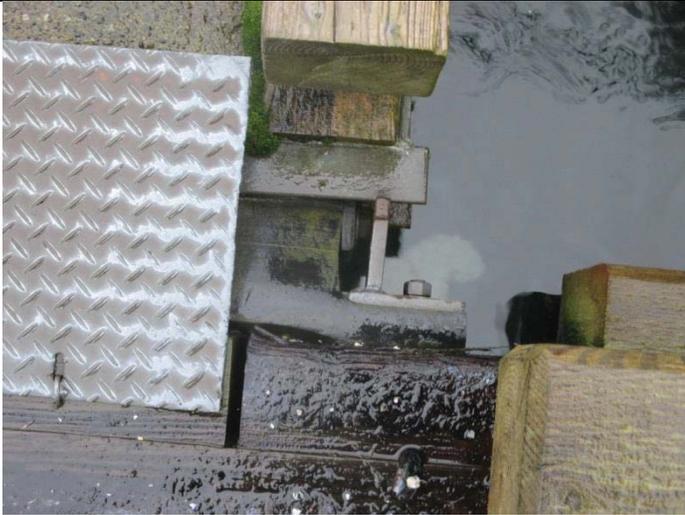
17. Compliant Hinge at C Float finger, note slight buckling of rubber fender material.

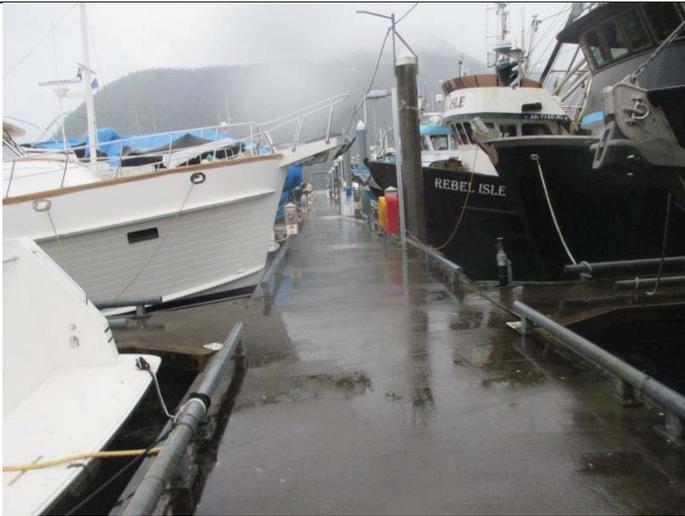
19. Typical New C Float section, note deteriorated weather conditions.

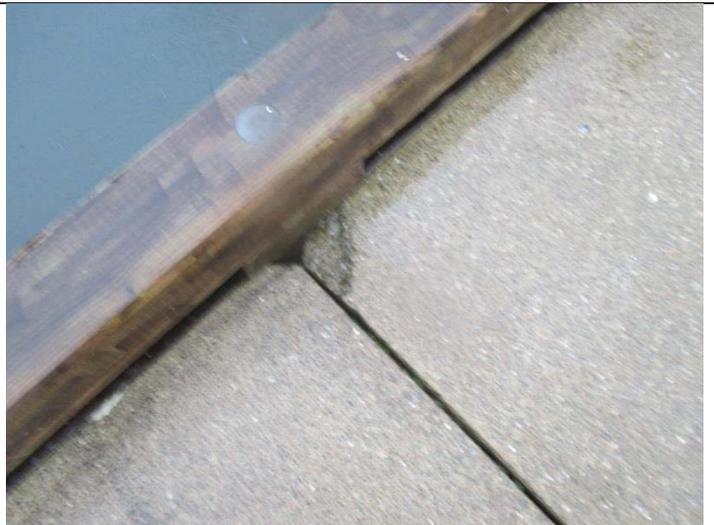
24. Small spall on B Float

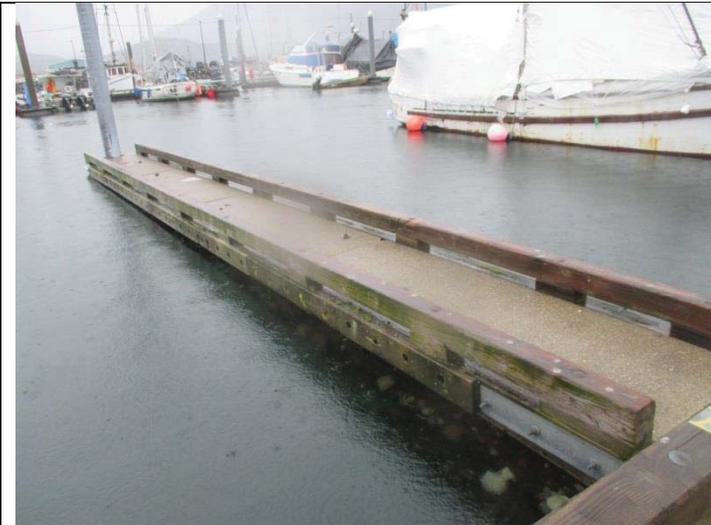
25. Loss of freeboard on B Float finger

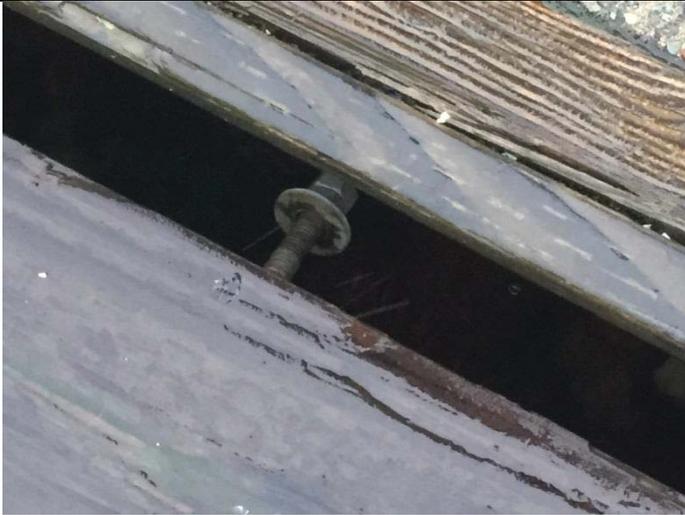
29. Damaged Thru - Rods at A Float to Headwalk Intersection

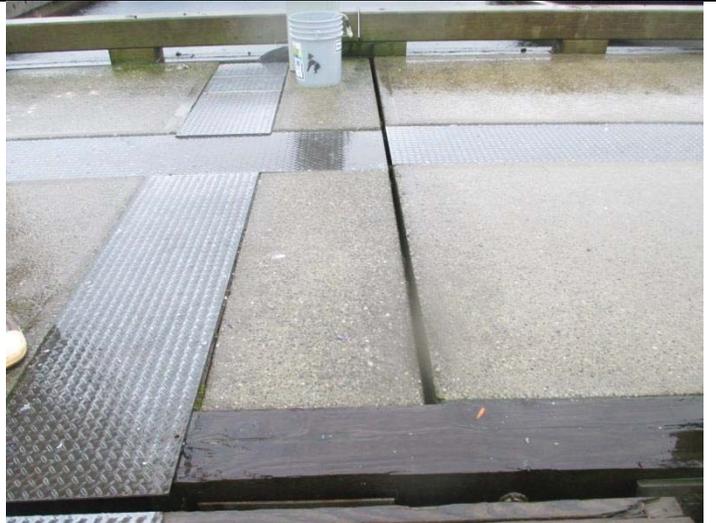
The older main walk floats sit with a slight list to the North. The list varies from 1-2" across the float, becoming more pronounced at the transformer location (Photo 30). The deck does not have any significant damage beyond normal wear and tear, but a few spalls appear to have been patched and repaired. There are small lips between portions of the concrete modules. These lips are more pronounced at transformer locations, and are indicative of worn thru-rods and wales, common to floats of this vintage. Bullrails on the main floats are in good condition with localized minor damage, and typical light moss vegetation. Damage was noted at the connection between A-float and the headwalk float. (Photo 29) It was noted that a thru-rod on the headwalk float had been pulled through due to forces acting on the connection. This may be caused by extra loads imparted into the floats by the gangway and mis-aligned piles near the float intersection pulling the floats apart during extreme tides. This is reportedly a semi-regular occurrence, and will be repaired by harbor staff. The newer sections of Float A are in good condition with no apparent damage beyond minor wear and tear that should be expected from floats in service for approximately 10 years.

30. Lip Between Concrete Modules on A Float

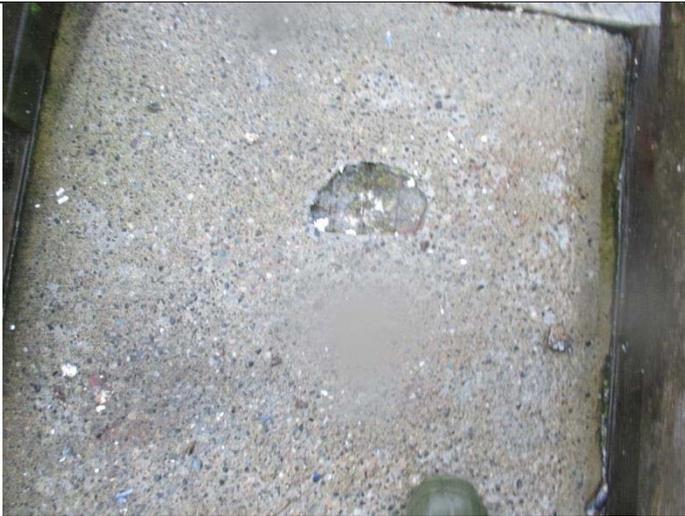
The older finger floats are generally in fair condition. The piano style hinges are less compliant to torsion than other hinge styles found throughout the harbor. This helps to control listing of the fingers somewhat where they connect to the main float, and there are reduced trip hazards at the transition area. Despite the rigid connection a lists of up to 7 inches were recorded on several fingers while many listed in the neighborhood of 1-3" (Photo 32). Finger floats were also observed to have minor cracks and spalls in the deck, with localized areas of significant spalling, exposing reinforcing steel and un-coated flotation (Photo 31).

31. Spalled Concrete on A float Finger

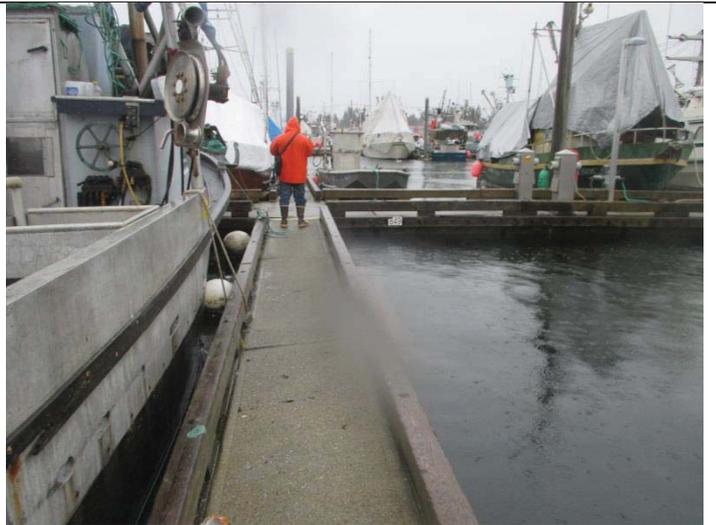
32. Twisted A float finger

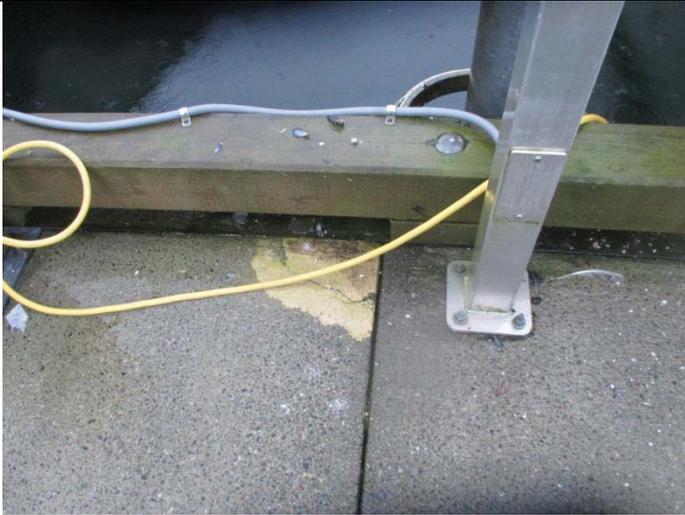
33. Spall Repair on A float

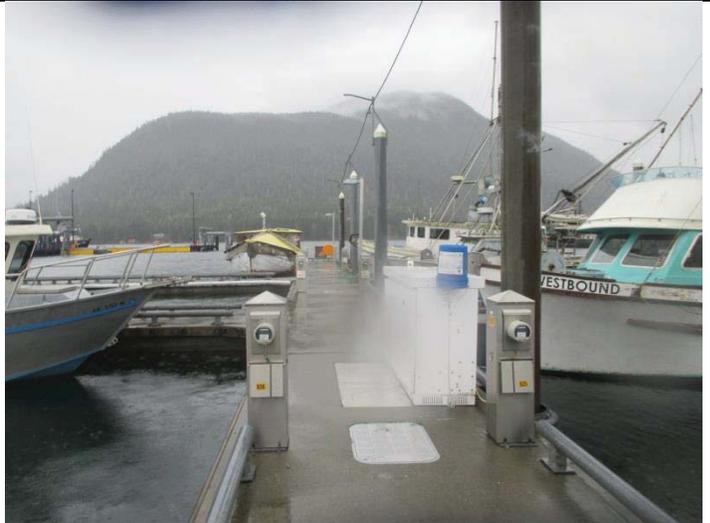
Float A is generally in fair condition (Photo 28). It has been subjected to periodic upgrades and maintenance over the years. The older portion (1983-84) has experienced wear consistent with its age while the portion installed in 2003-2004 is still in good sound condition (Photo 34).

34. A Float, Newer main float sections

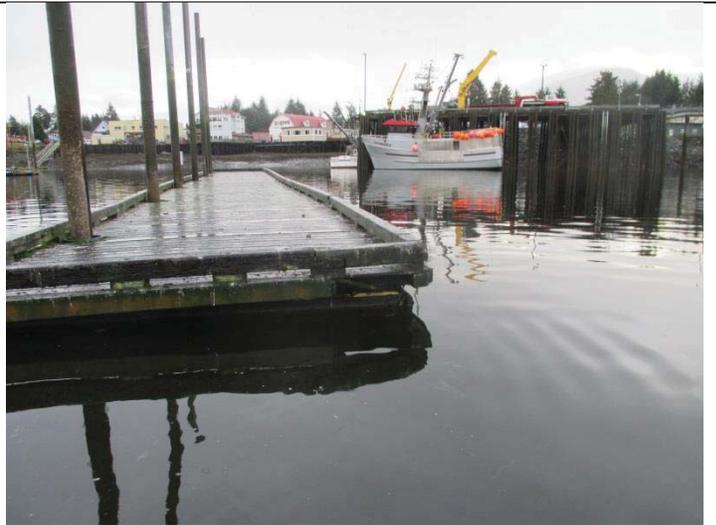
39. Utility Float, Damaged / Missing Rub Strip

Based on its heavy use and its condition, it is recommended that the existing float be replaced in the next 5 years. The existing float appears to be constructed similar to standard mooring floats, which are not well suited for use as net floats. A heavy duty timber or concrete float with a high live load capacity is recommended at this location. Installation of sacrificial anodes on the guide piling is recommended if they are to be re-used for the replacement float.

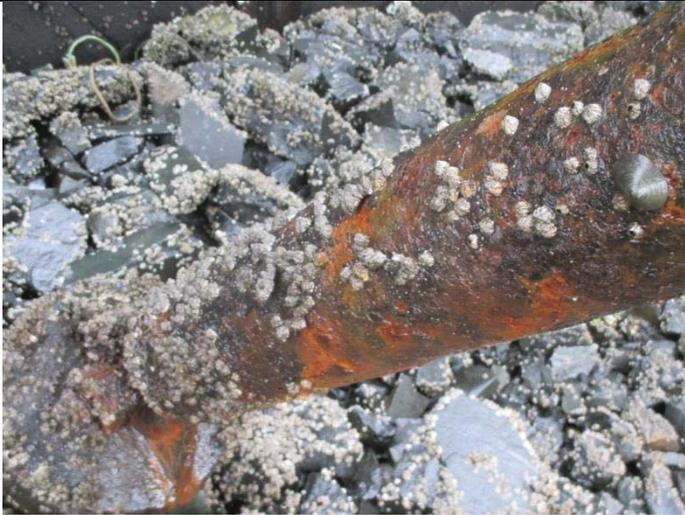
48. Corrosion on Fender Pile Bracing

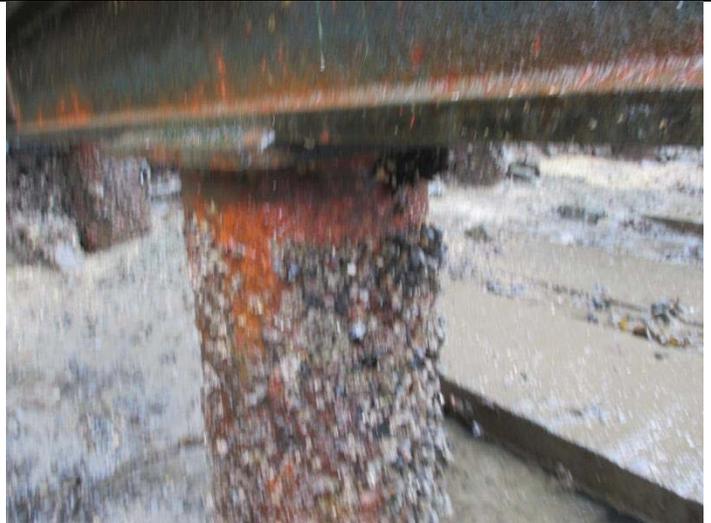
49. Corrosion on Grid Bearing Piles and Grid Caps

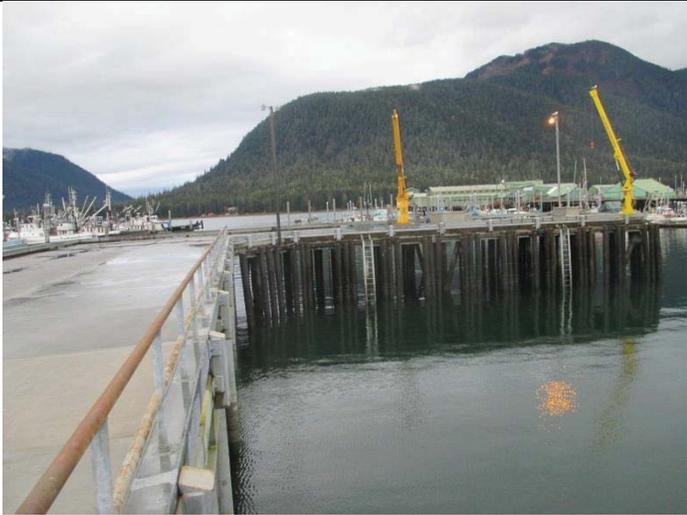
The crane dock (Photo 50) is in good condition, having undergone recent widening, fender pile replacement, and sacrificial anode installation (Photo 54). The structure appears to have 35+ years of useful life remaining with continued maintenance.

50. Crane Dock

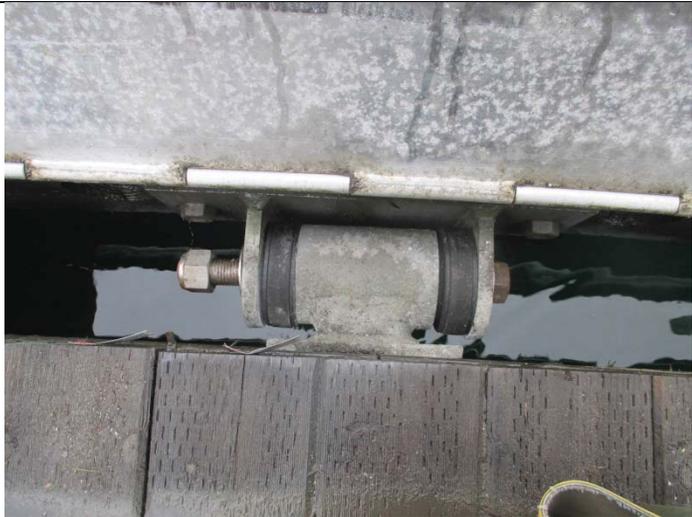
3. Loose Nut at Gangway to Main Float Connection

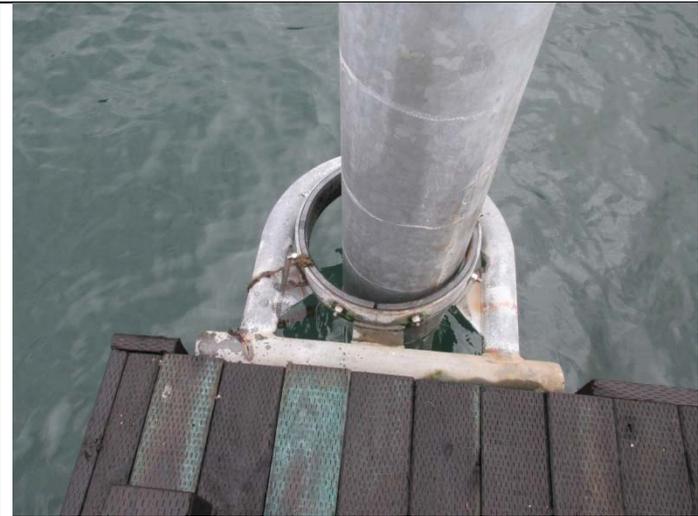
7. Corrosion on Pile Hoop at Replacement Floats

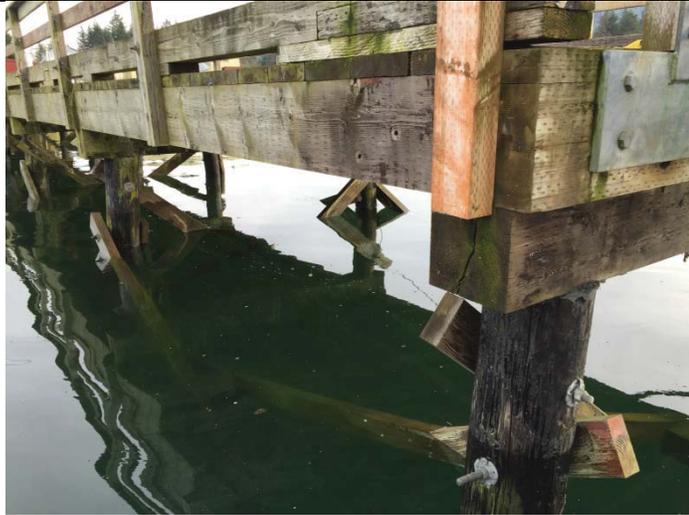
9. Approach Configuration. Note Cracked Pile Cap

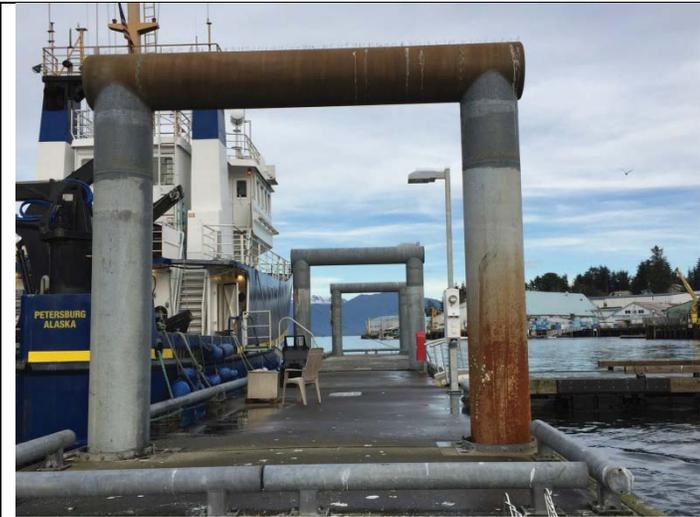
5. Corroded guide pile.

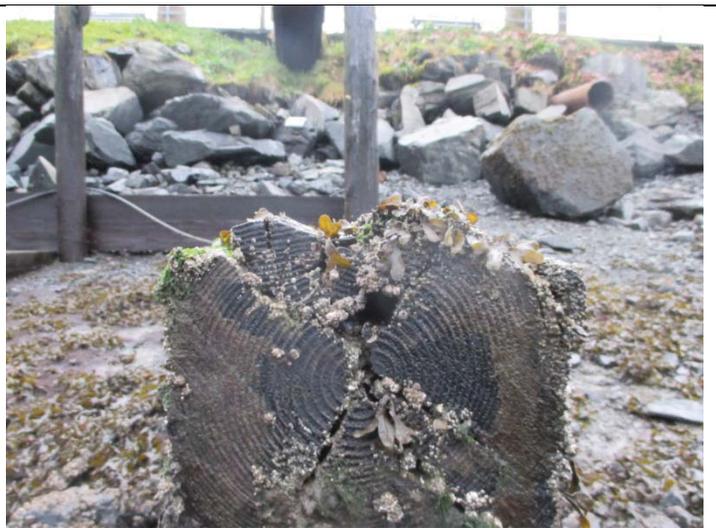
8. Damaged Grid Beam End

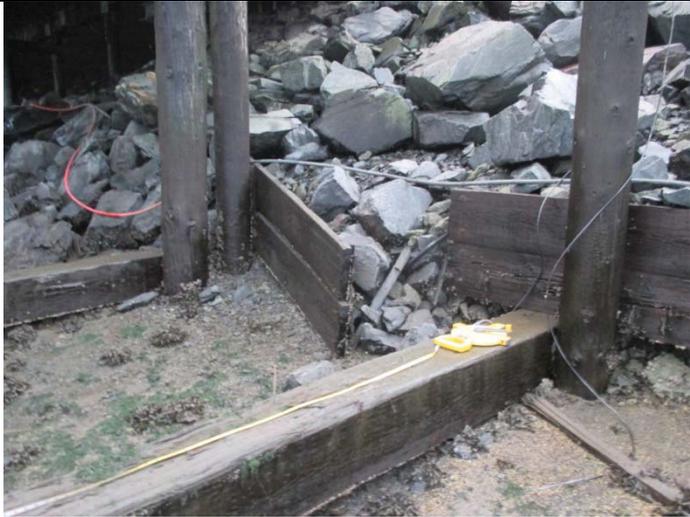
9. Blow out at Timber Retaining Wall, South of Approach.

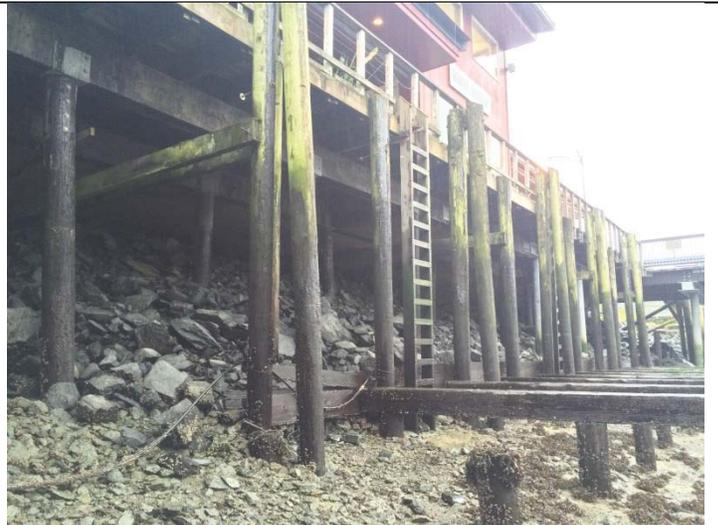
12. Looking South Towards Approach. Note Removed Grid Beam and Damaged Retaining Wall .

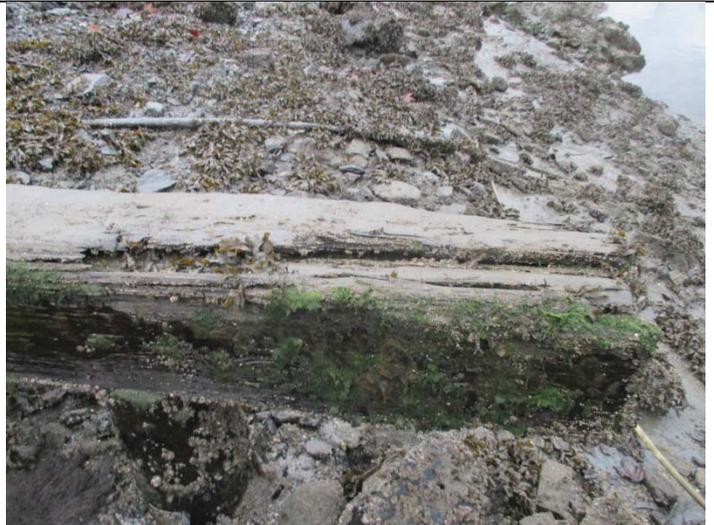
16. Heavily Damaged Grid Beam End .

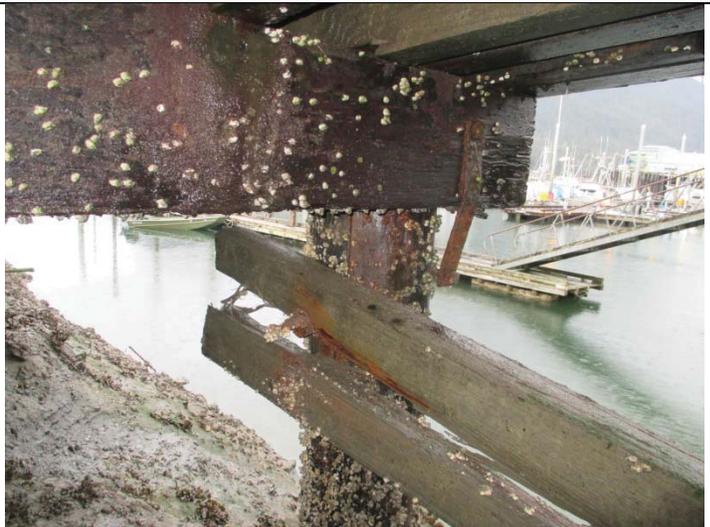
20. Broken Bracing and Damaged Pile to Cap Connection .

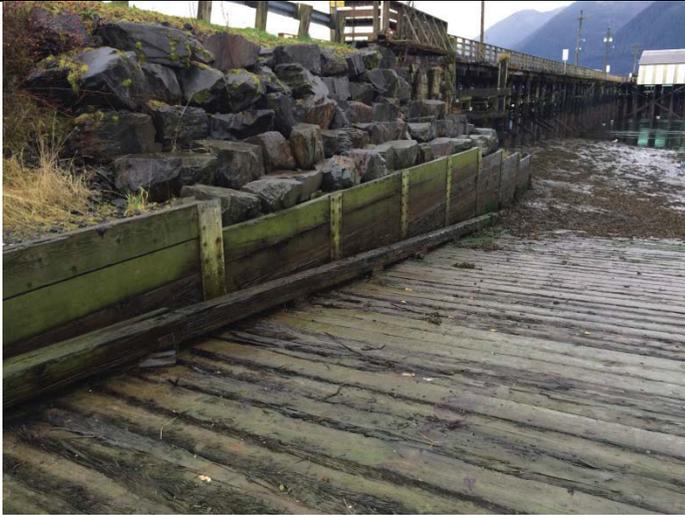
**23. Worn/ Damaged Decking and Retaining Wall.
Note damage to bullrail.**

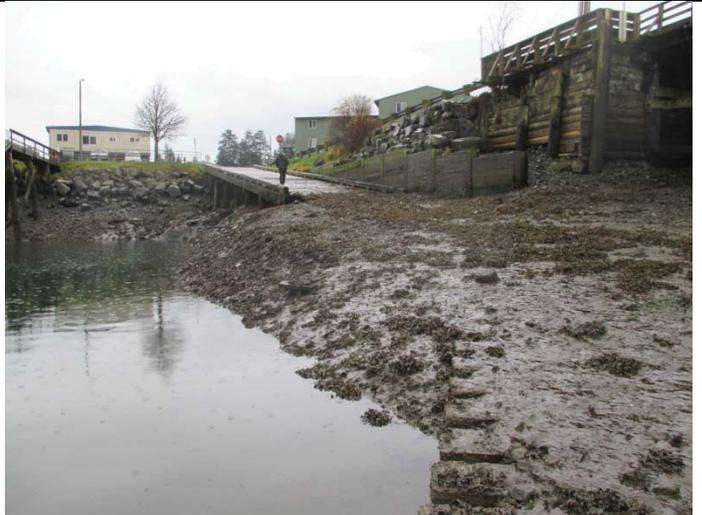
24. Concrete Planks, Buried and Partially Undermined.

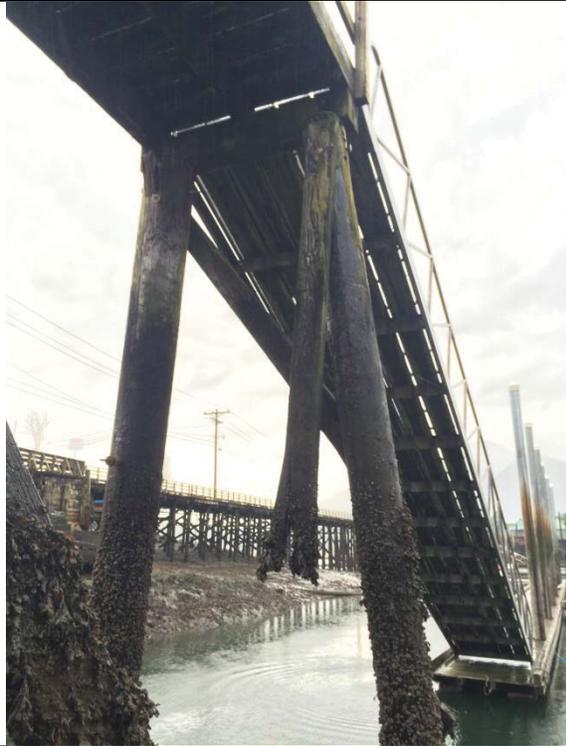
28. Broken Bracing at Skiff Float Approach, Note Split at Pile Top (Left) .

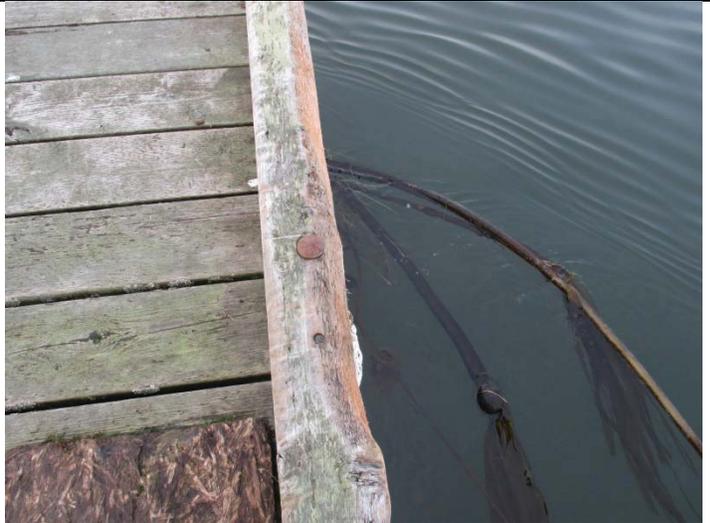
6. Papke's Worn Bullrail and Decking.

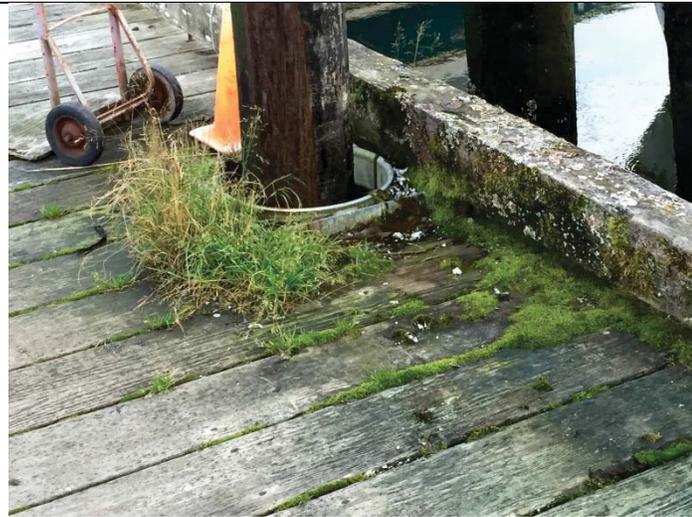
9. Wear on guide pile, note vegetation

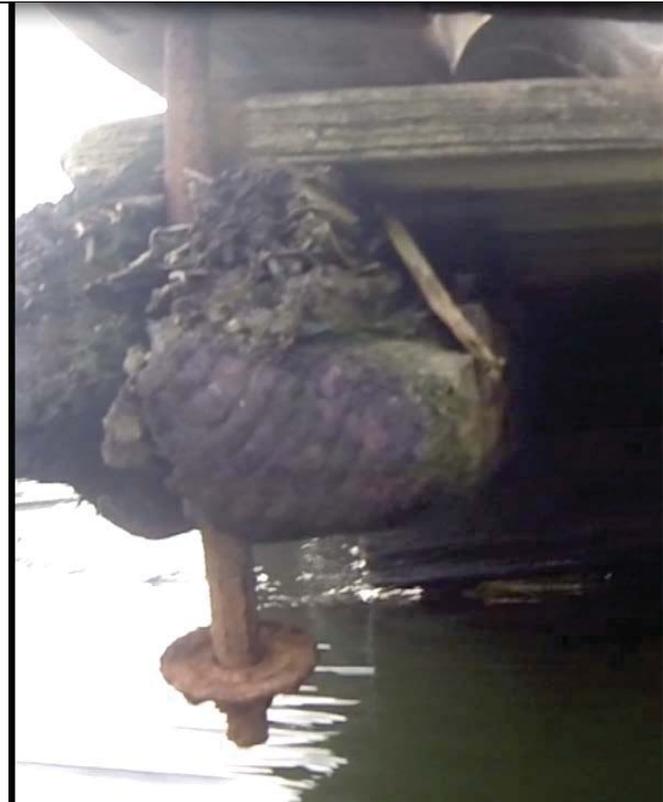
11. Damage sill and bolt, note corrosion.

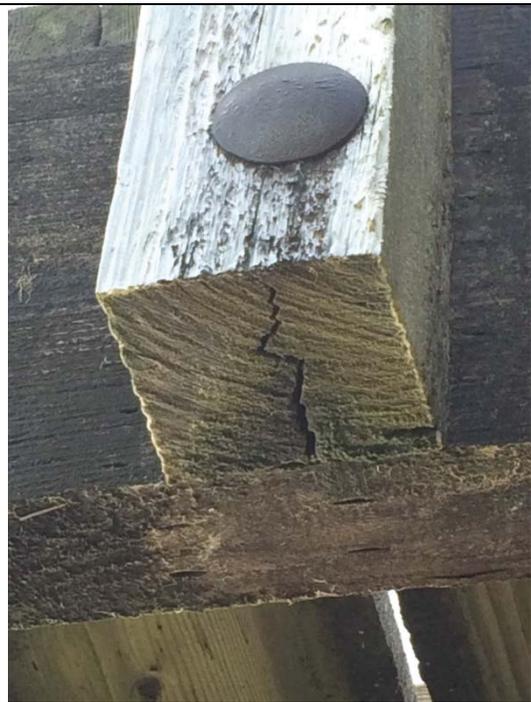
4. Typical Crack at Handrail Post

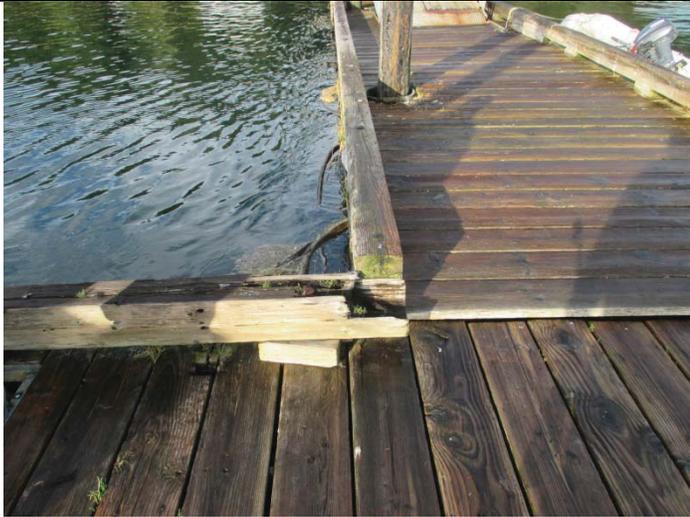
9. Damaged bullrail and lip at float intersection

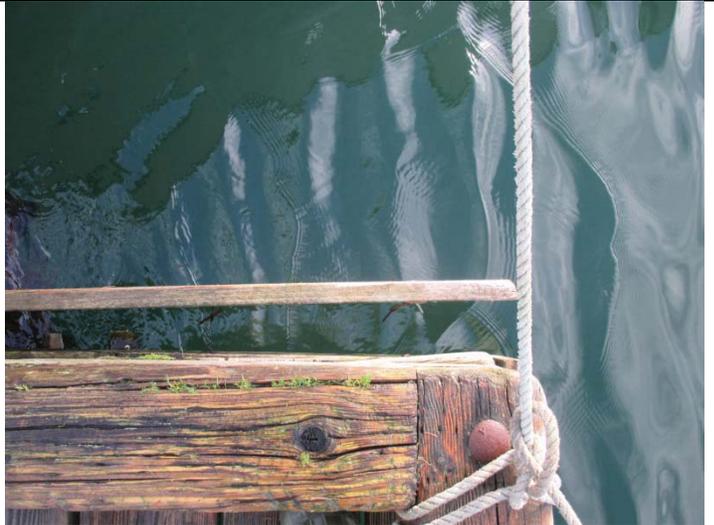
12. Worn Bullrail and Damaged Rub Board
