Project: **Kiseno Street Water Main Replacement (across Hammer Slough)**

Department: Water

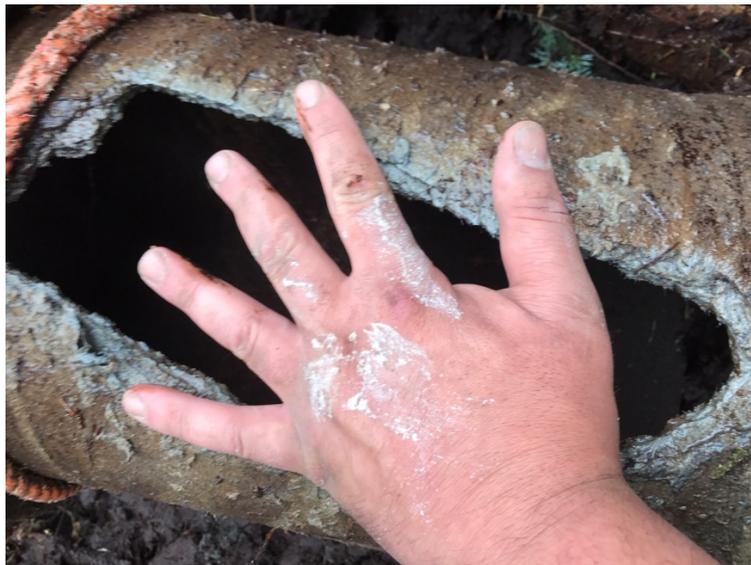
A recent blowout of a Transite water main.
