Petersburg Borough

Harbor Facilities

Condition Assessment Report

Presented to:
Borough of Petersburg
November 24, 2015

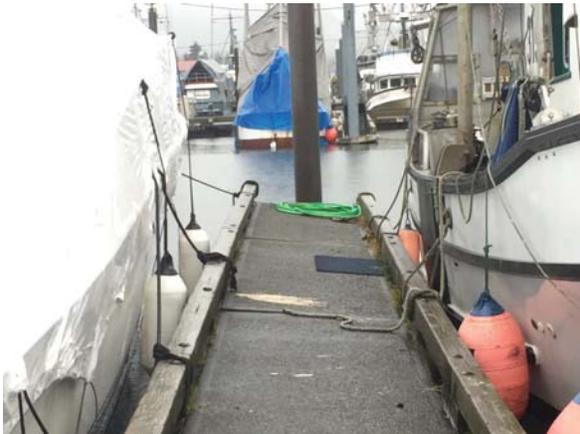
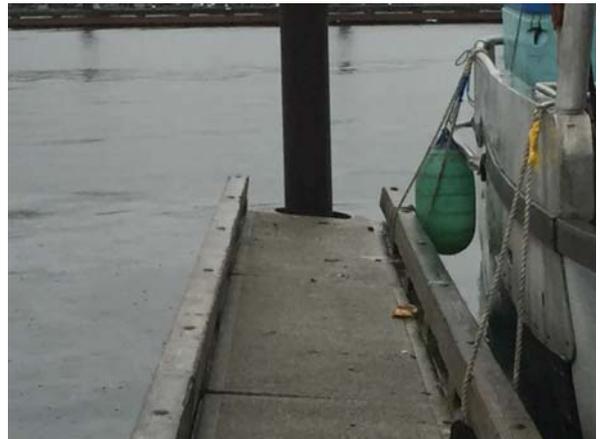
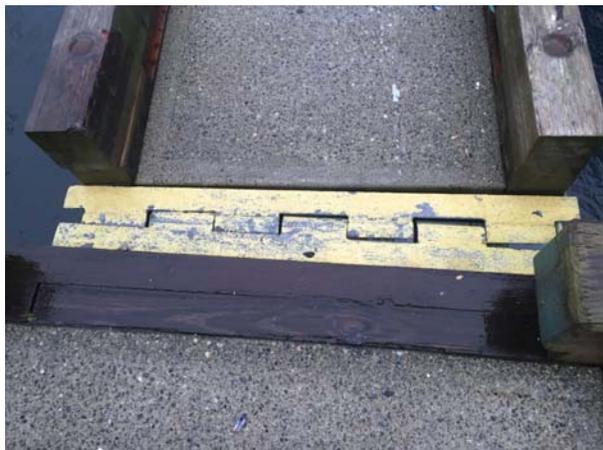
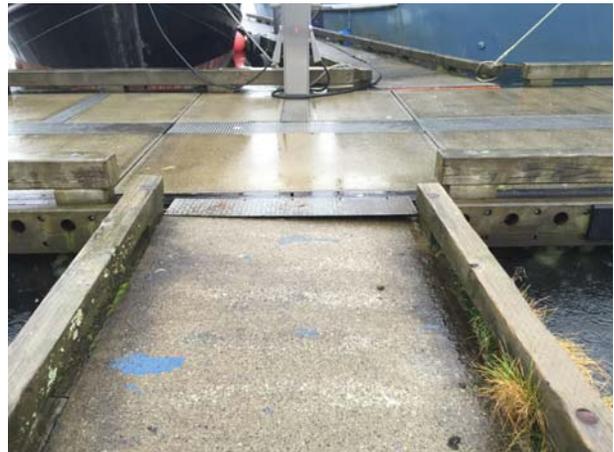
Vessel Stall Floats

Many of the older existing vessel stall (i.e. “finger”) floats have begun to lose freeboard, and some are experiencing significant rotational twist about their longitudinal axis. It is anticipated that replacement of these stall floats may become necessary in the near term.

The average condition of the stall floats is fair to poor, and it is expected that it will not be serviceable beyond another 15 years.

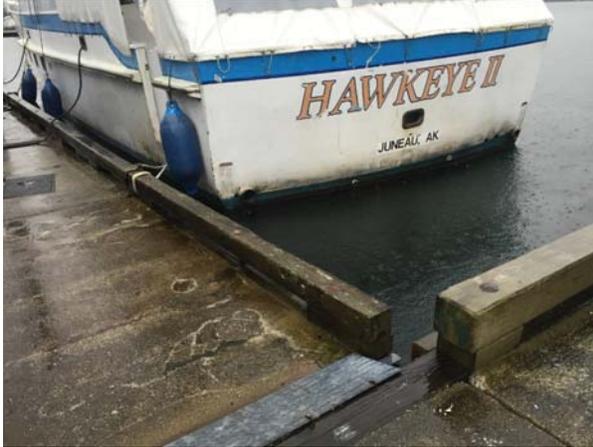
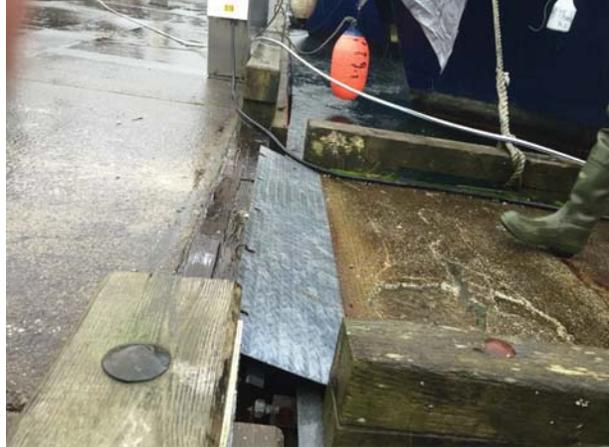
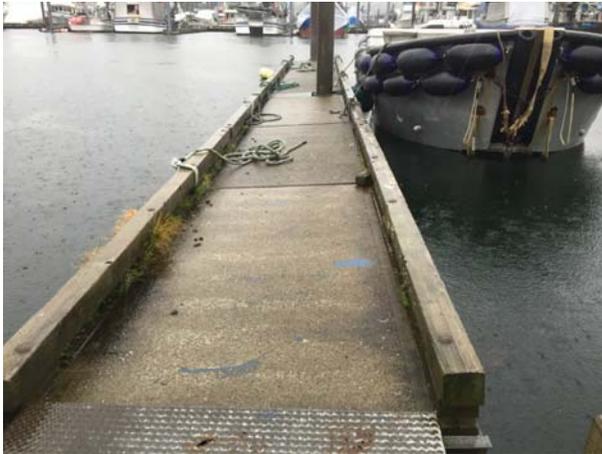
Mainwalk Float "D"

It is thought that mainwalk float "D", being the only unimproved mainwalk from the original construction, will need to be replaced entirely.

The current condition of mainwalk float "D" is fair to poor, and it is expected that it will not be serviceable beyond another 15 years.

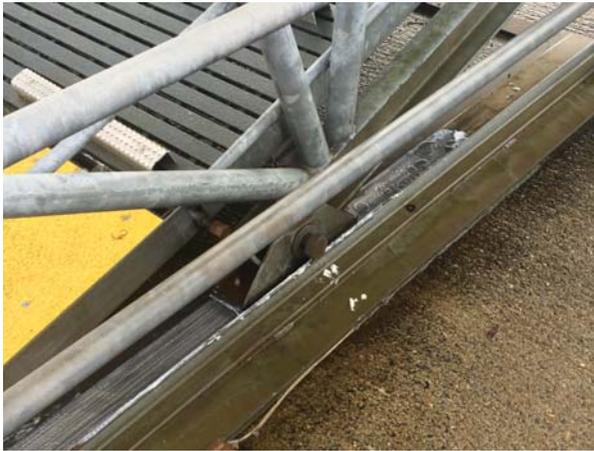
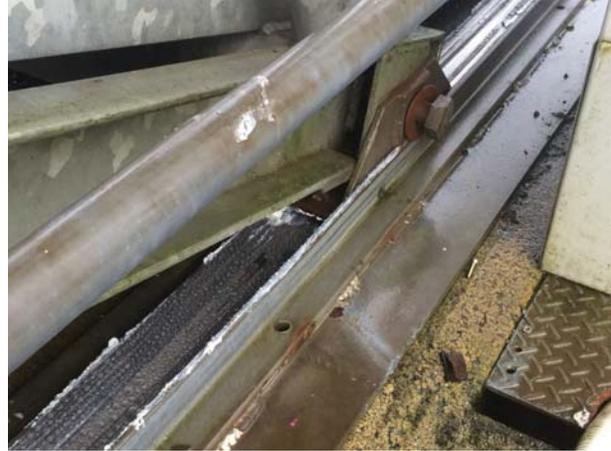
Gangway Landing Issues

The seaward end of the existing gangway has experienced long-term issues with binding in its lateral restraint system. In addition, it is possible that this issue has been the cause of damage observed at the boundaries of the existing gangway landing float with other adjacent floats.

It is expected that continued binding of the gangway, as it attempts to slide longitudinally on the deck of the gangway landing float with the changes of tide, will eventually cause significant damage to the landing float and to the adjacent floats and attachment hardware. Given the seriousness of the damage, and the lack of a proven strategy for dealing with this issue to date, it is felt that engineering analysis leading to an immediate design solution would be prudent.

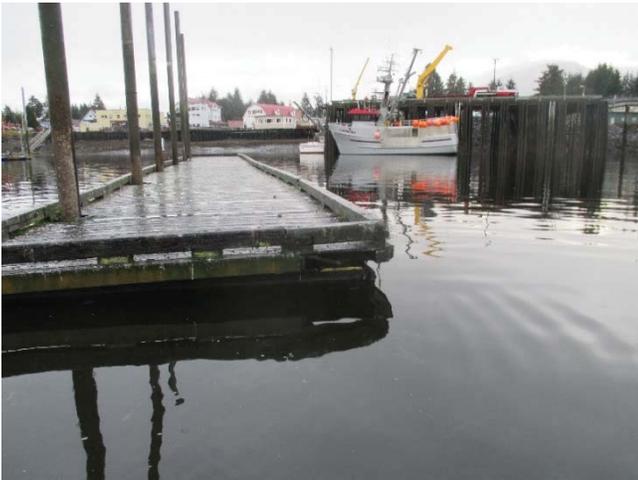
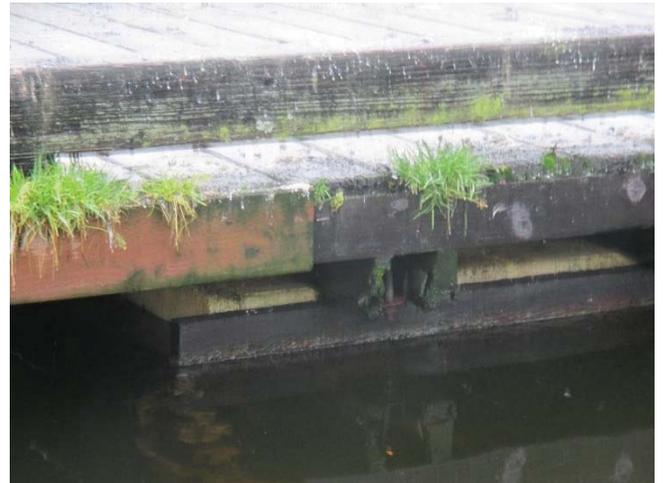
UTILITY/NET FLOAT

The current condition of the utility float is poor, and it's expected that it will not be serviceable for its current usage beyond the next 5 years. The float has suffered apparent damage and decay to the timber sills that support the flotation billets. The decking and bullrail are showing signs of wear, and much of the rub board is damaged or recently repaired. Reportedly, portions of the float regularly become submerged when loaded with nets and gear, making it un-suitable for the intended purpose in its current condition. The float may be replaced with a heavy duty concrete or timber replacement float, and the guide pile can be re-used.

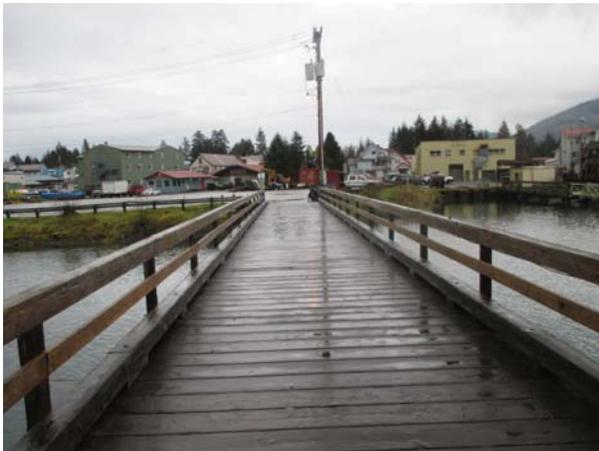
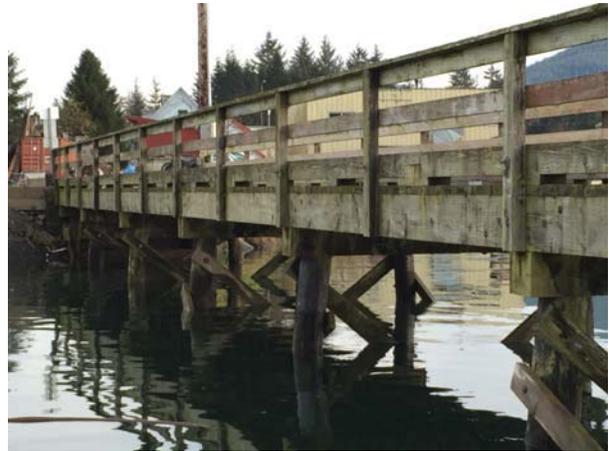
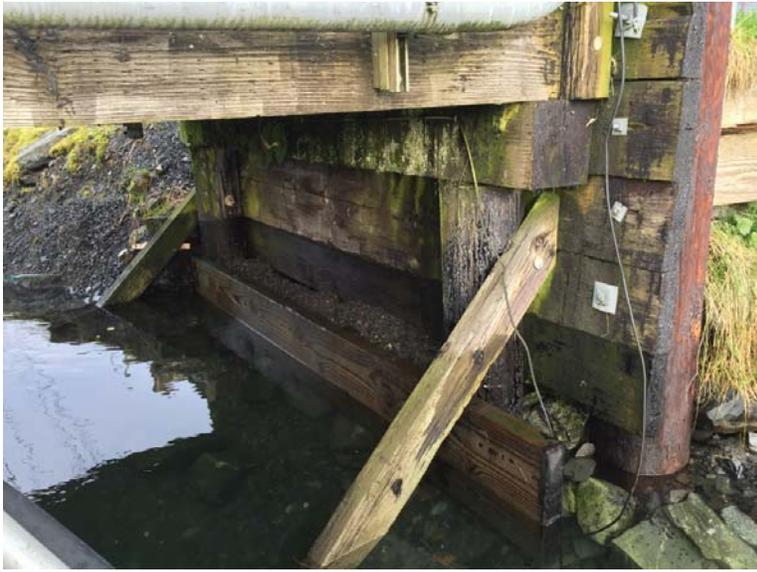
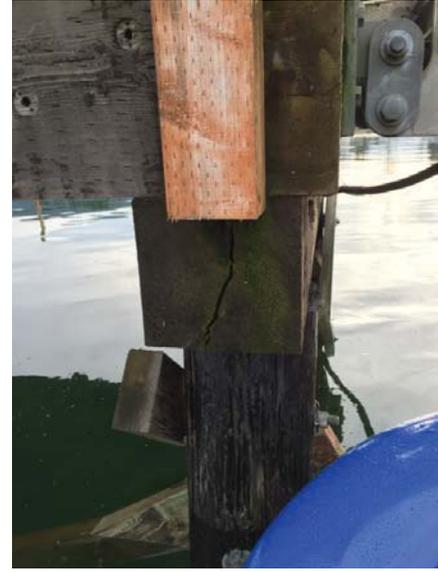
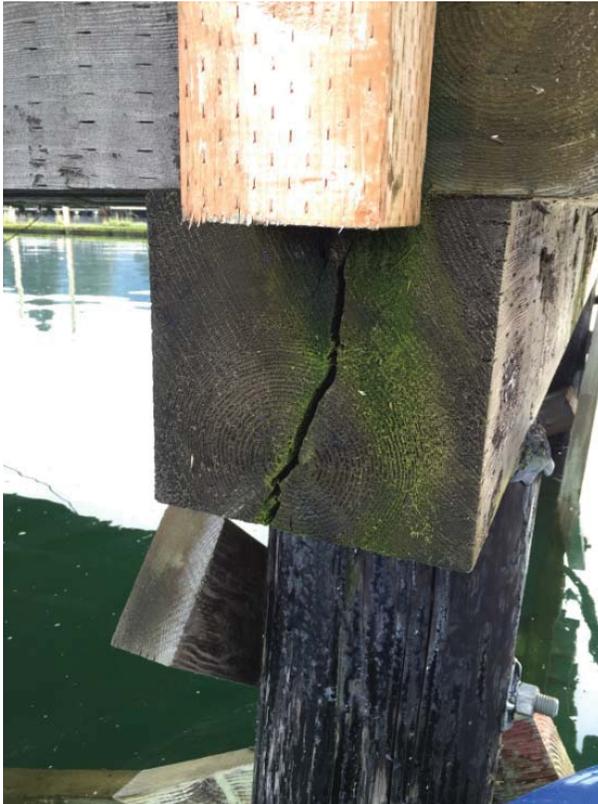
The remaining existing element of construction of immediate concern is the timber approach trestle. It is expected that at some point this structure will need to be either upgraded, or replaced altogether.

The current condition of the timber approach trestle is Good to Fair, and it is expected that it will not be serviceable beyond another 20 years. The replacement system could be constructed similarly to the current arrangement, except utilizing structural steel pipe pile and approach framing. The existing gangway structure would be re-used.

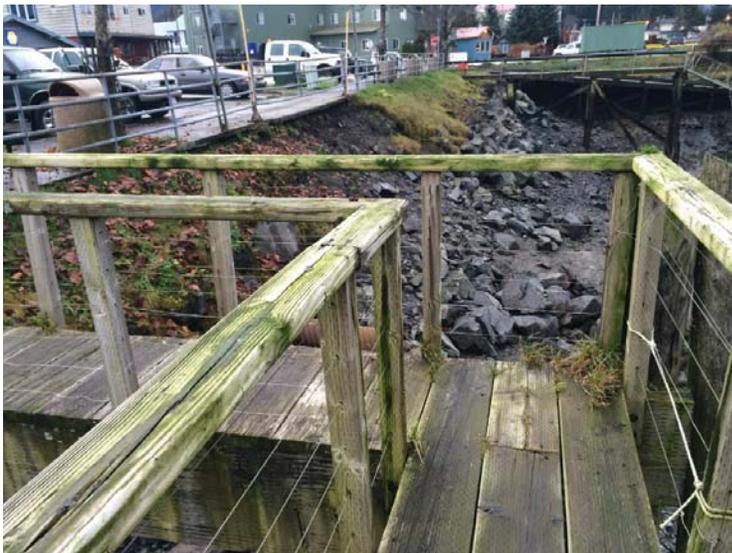
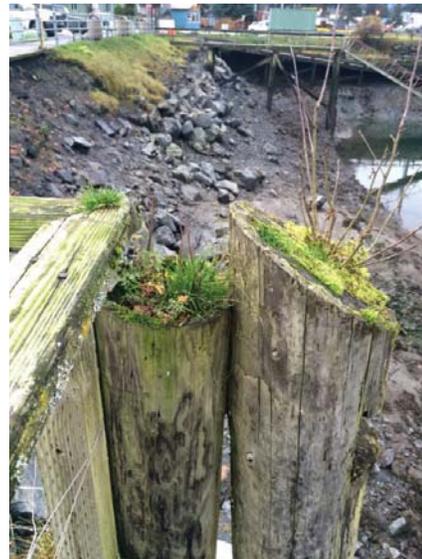
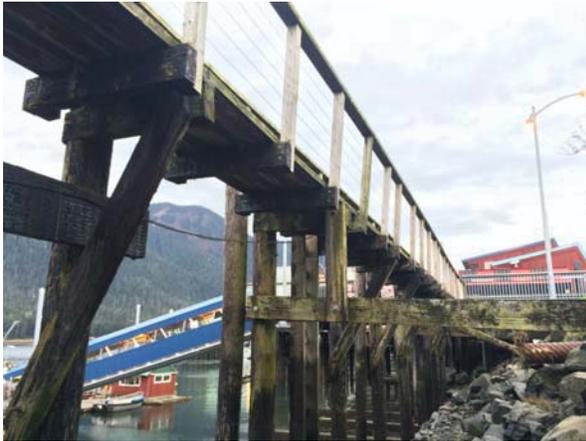
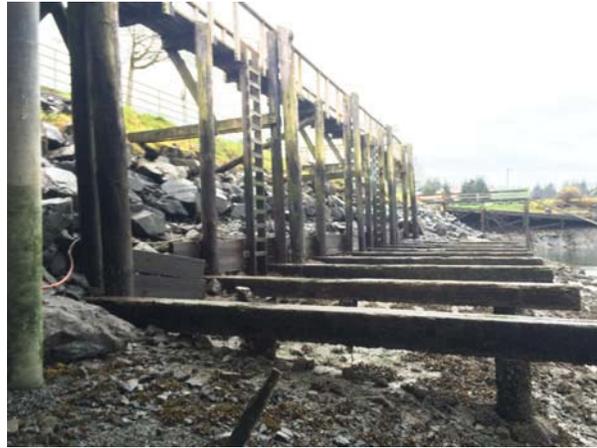
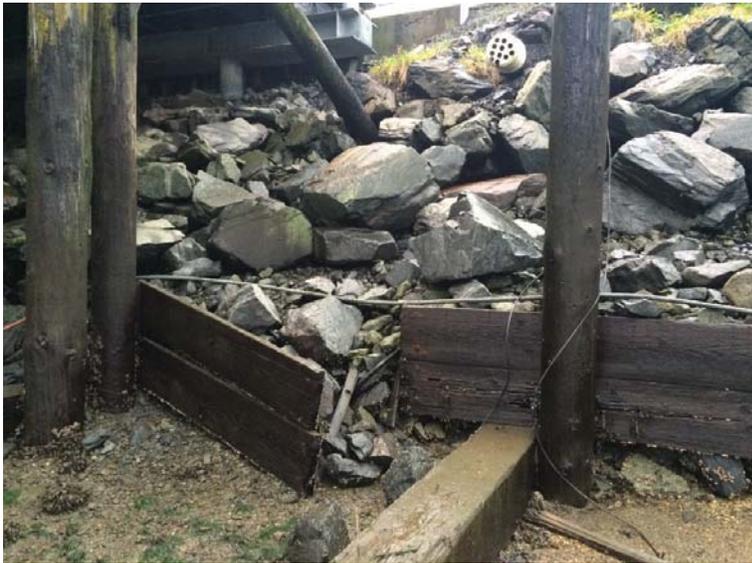
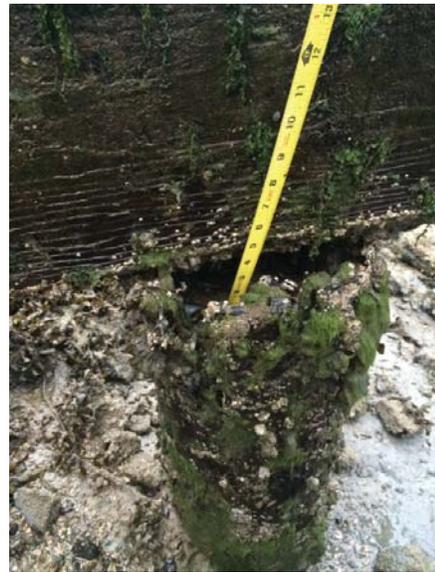
Timber Boat Grid and Catwalk

It is expected that the northern group of timber boat grid sleepers and associated pile will eventually be replaced by an upgraded boat grid. Our understanding at this time is that this grid sees fairly consistent use by harbor patrons. On the other hand, the southern group of timber boat grid sleepers, along with the existing timber catwalk above them will likely not be replaced upon demolition.

The current condition of the northern group of sleepers ranges from fair to poor, and it is expected that they will not be serviceable beyond another 5-10 years. The replacement of the northern group is expected to consist of a similar number of grid beams at similar spacing, with structural steel pipe pile and hot-rolled structural steel sleeper shapes.

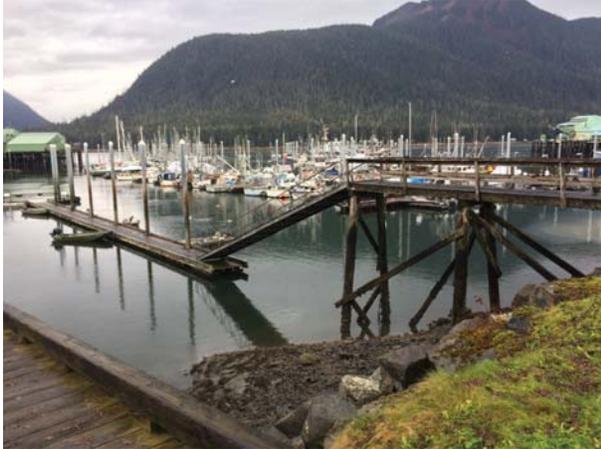
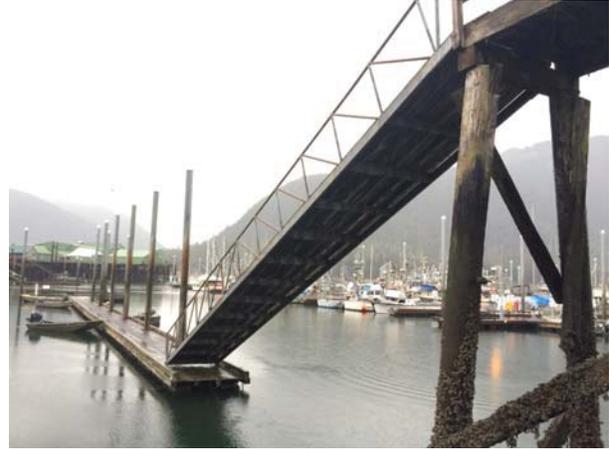
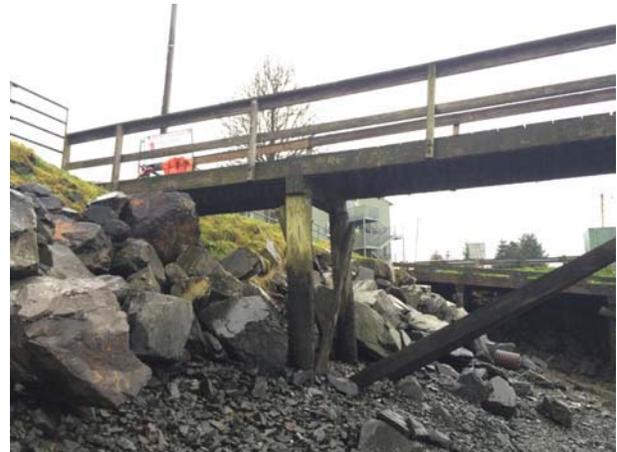
Approach Dock, Gangway, Skiff Float and Troller Float

It is expected that the existing approach dock, gangway, skiff float and troller float will eventually be replaced.

The current condition of this system is fair, and it is expected that it will not be serviceable beyond another 10-15 years. The replacement of the system with a similar arrangement, will include necessary dredging, retention structure, and structural steel pipe pile and approach framing, an ADA accessible gangway, and modern concrete or timber float units.

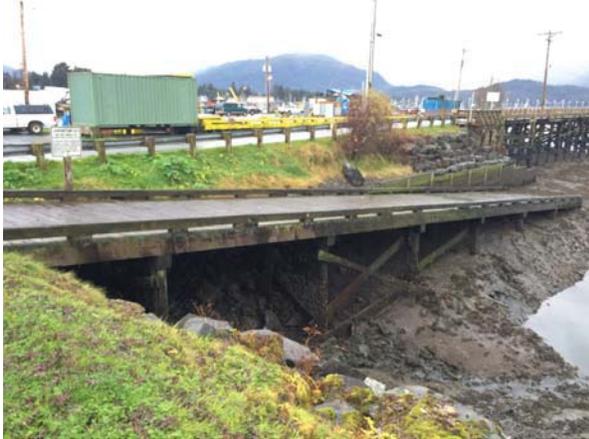
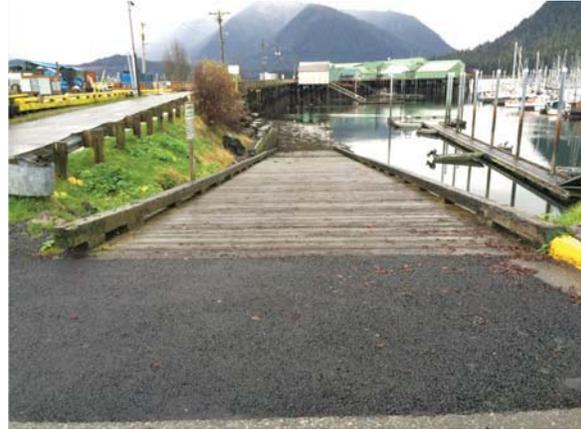
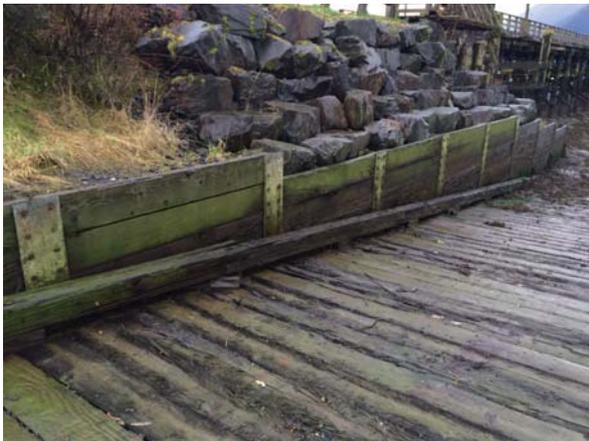
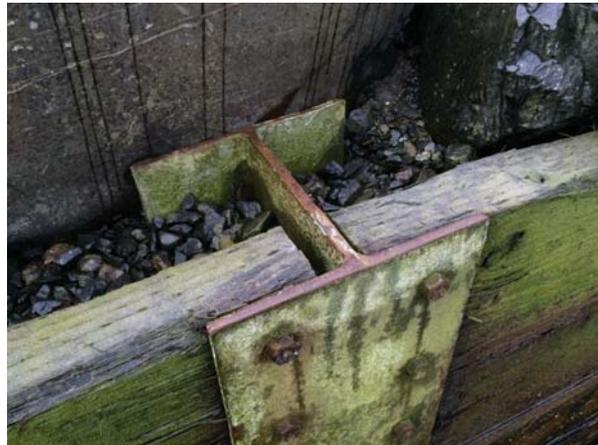
Timber Launch Ramp

It is expected that the existing timber launch ramp will be demolished and not replaced.

The current condition of the ramp is POOR, and it is expected that it will not be serviceable beyond another 5 years without significant repairs or maintenance.

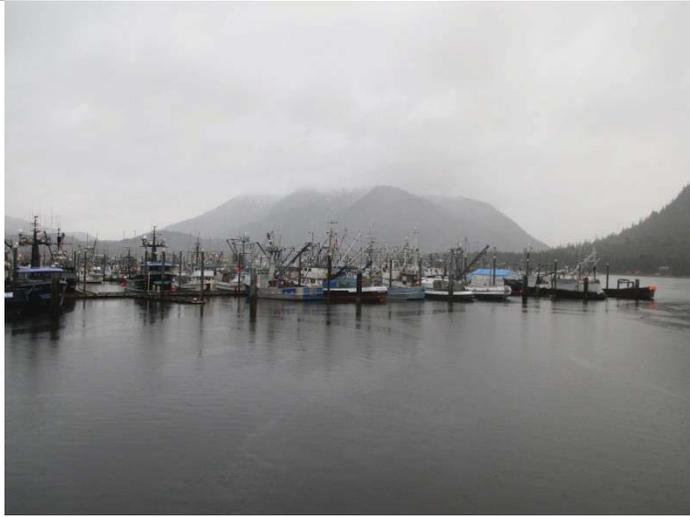
1. South Harbor Float System

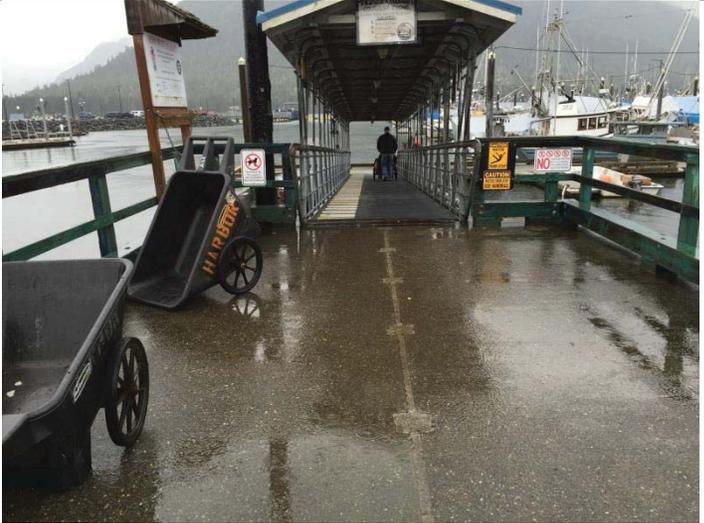
2. South Harbor South Gangway

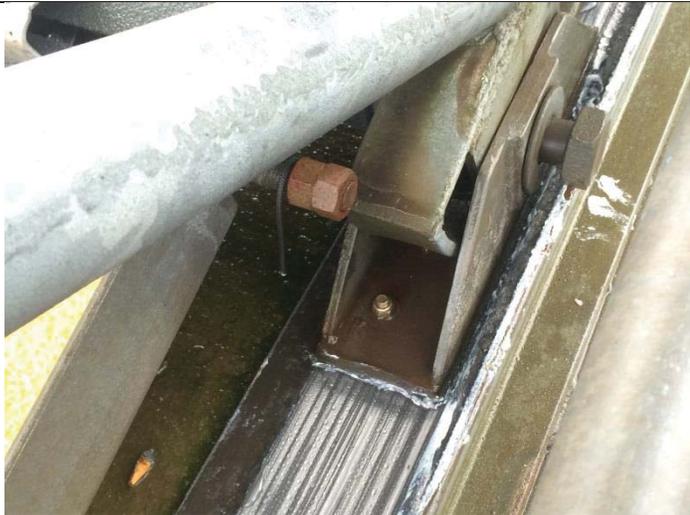
3. South Gangway Shoe Binds in Tracks

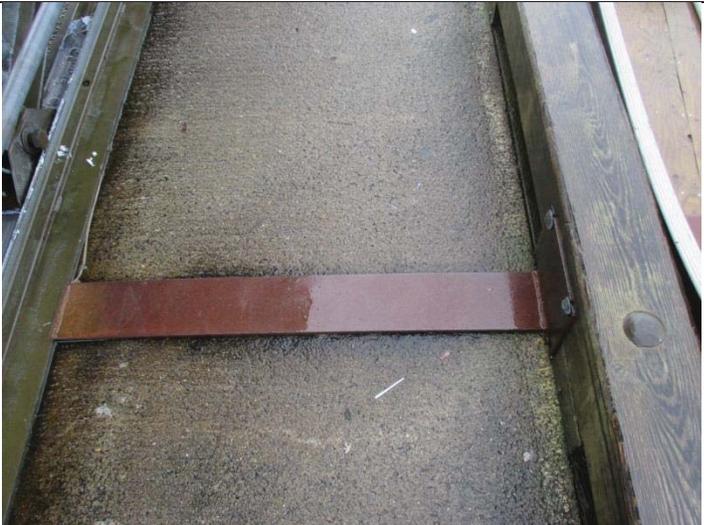
4. Steel straps used to hold gangway tracks

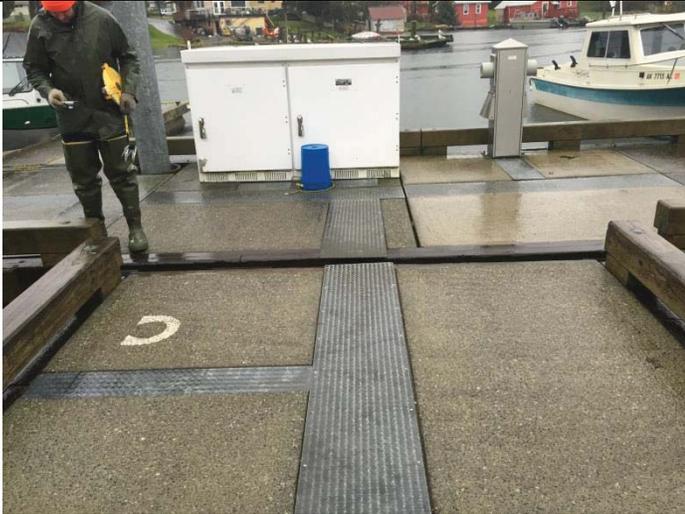
11. Headwalk – C Float intersection, Note lip.

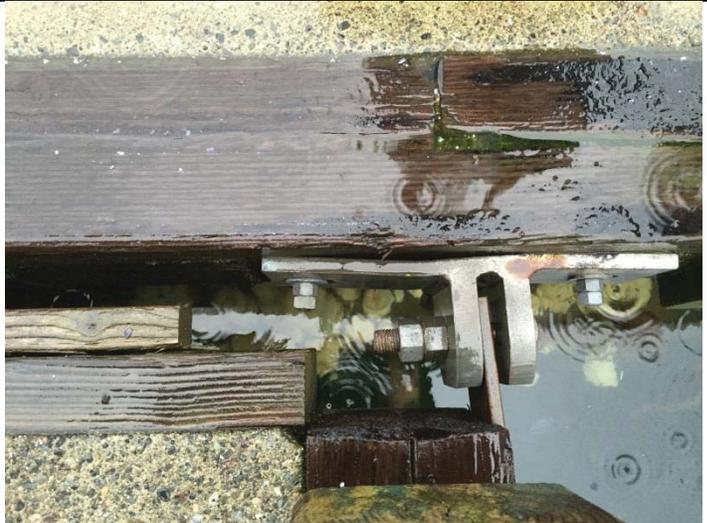
12. Bent Hinge/Plate at Headwalk – C float intersection.

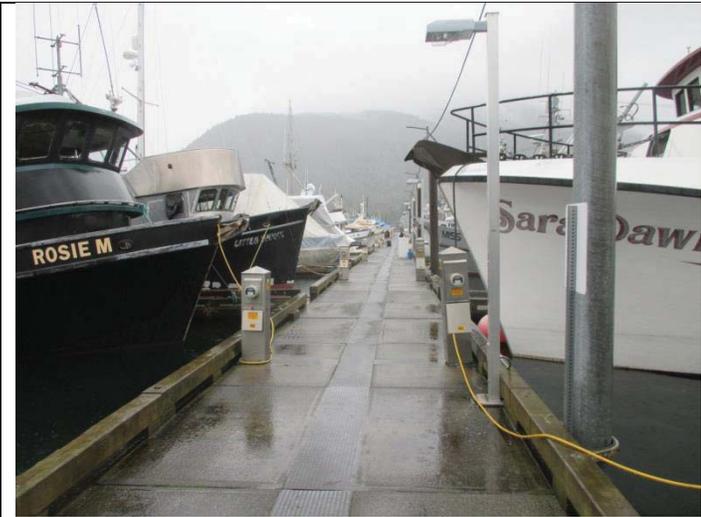
13. Typical C Float

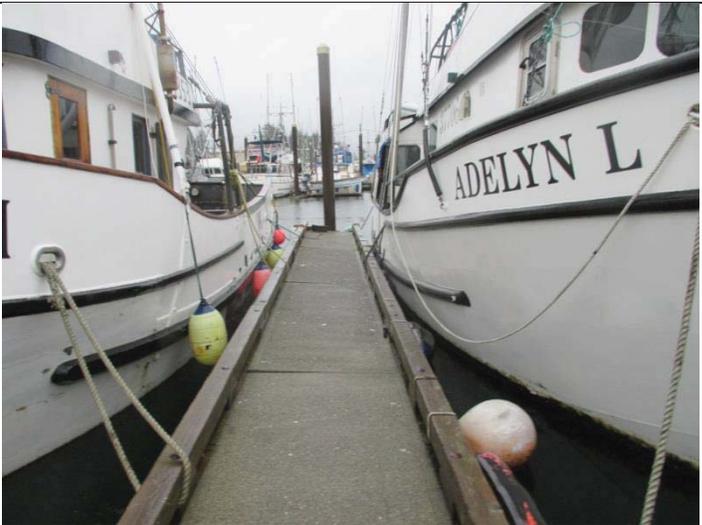
14. Twisted C Float Finger, not displacement between concrete modules.

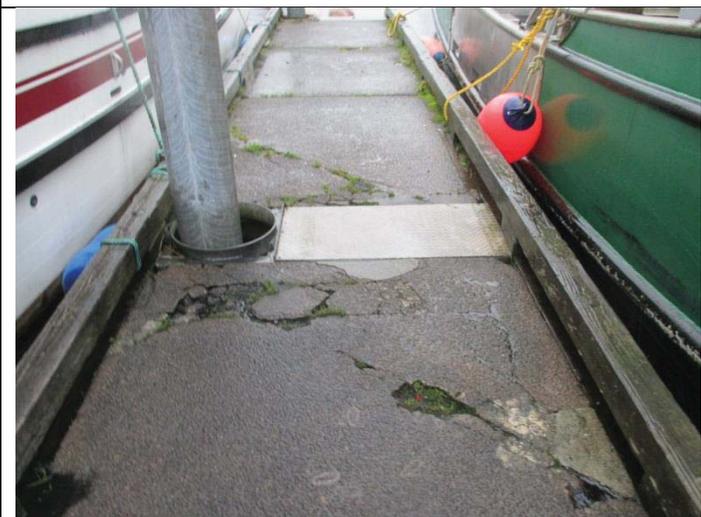
15. Heavily cracked/spalled C Float finger

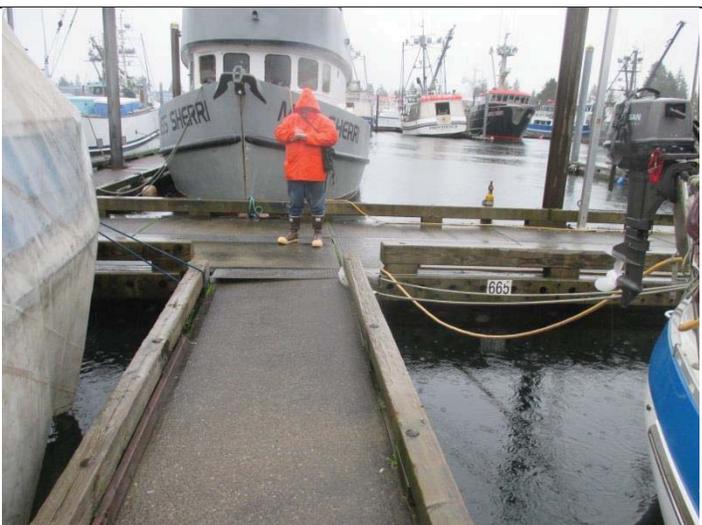
16. Twisted C float finger with trip hazard at transition plate

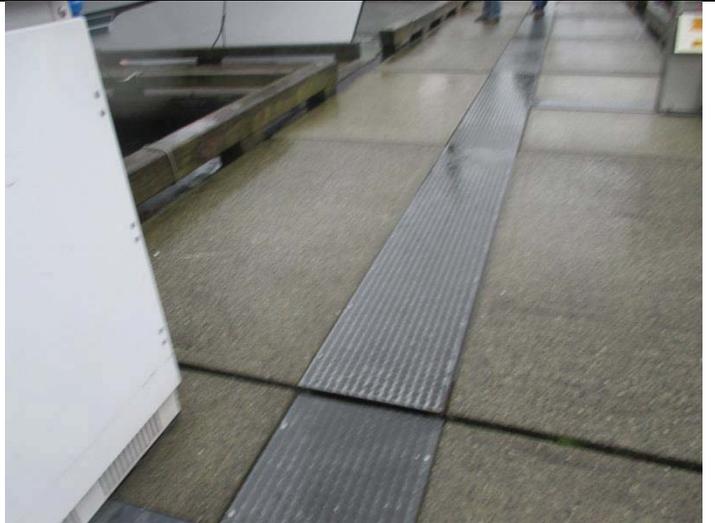
18. Lip between concrete modules at transformer locations

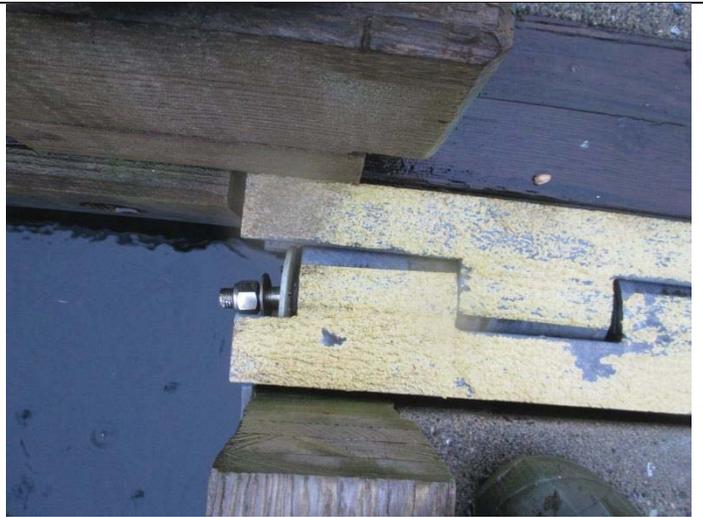
26. Stressed Finger Float piano hinge

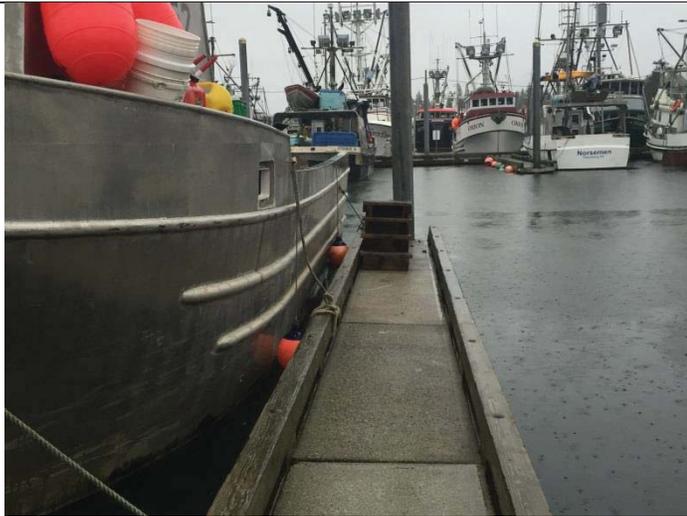
27. Twisted B Float finger note displacement between concrete modules

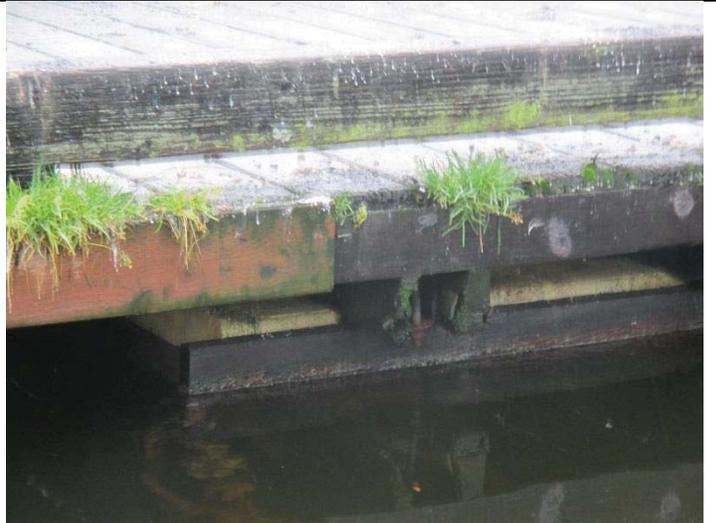
37. Utility Float, Split Timber Sill, Note Vegetation.

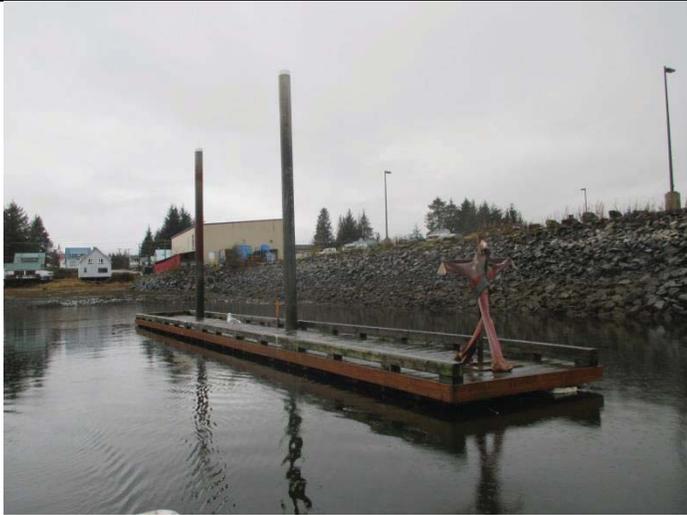
39. Utility Float, Damaged / Missing Rub Strip

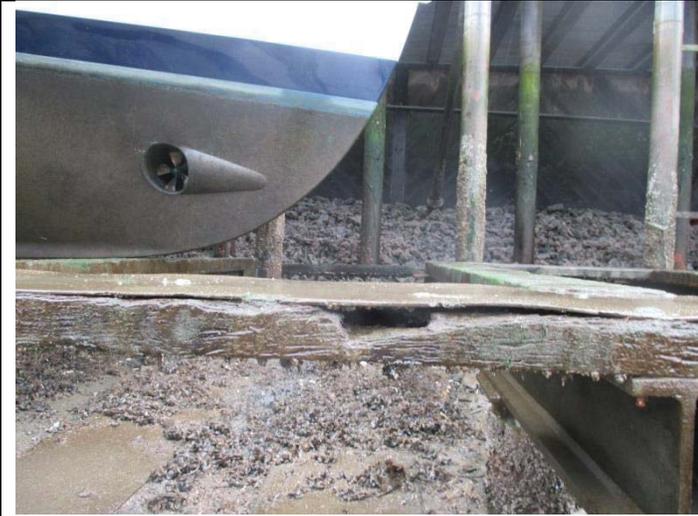
46. Rotted/Damaged Timber Walking Plank

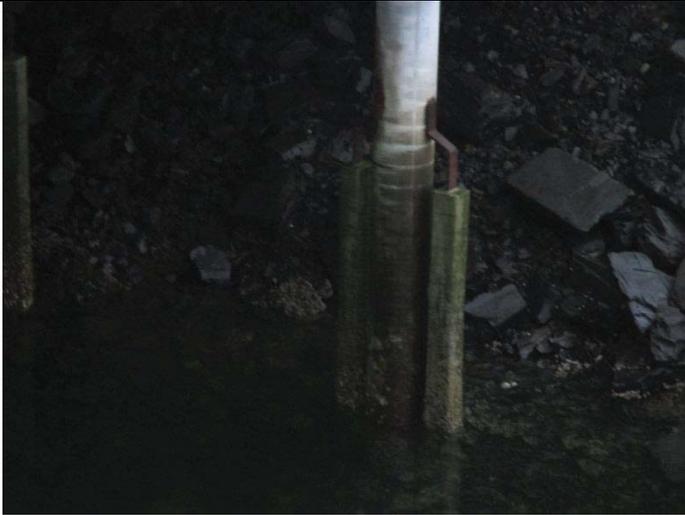
54. Crane Dock Anodes

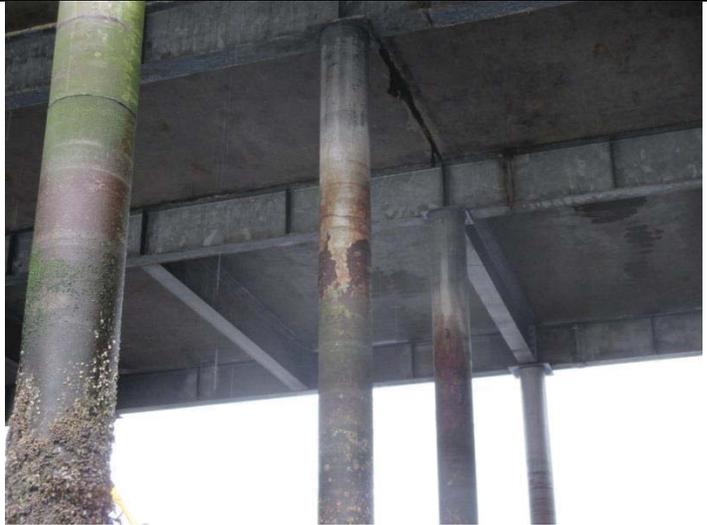
55. Typical Crane Dock Piling, Note Localized Corrosion in intertidal zone.

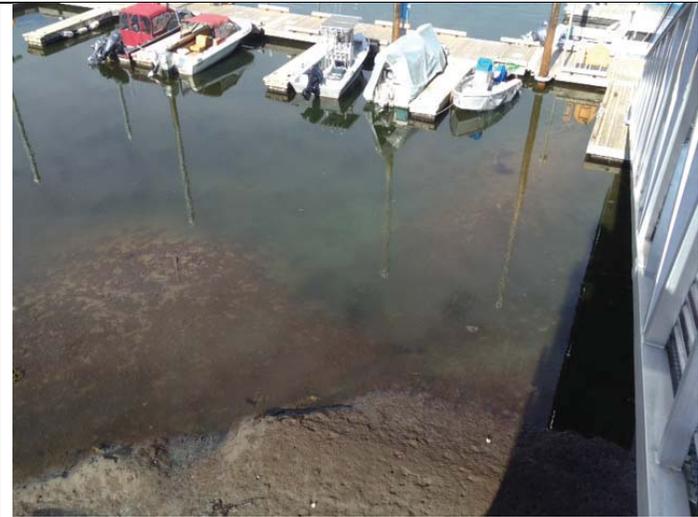
5. Middle Harbor at Low Tide. Note Area Adjacent to Gangway Landing

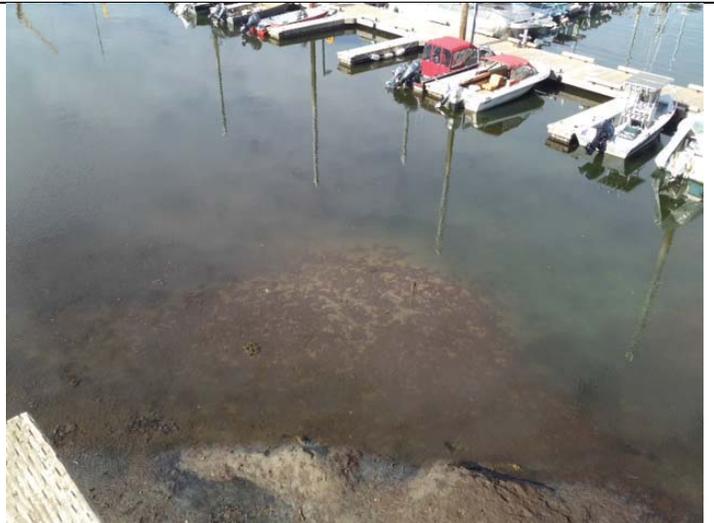
6. Middle Harbor at Low Tide. Slip Access is Limited.

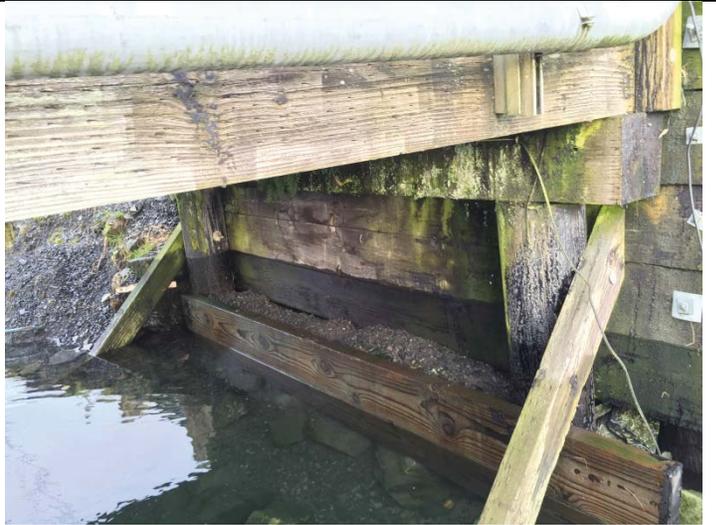
10. Approach Backwall

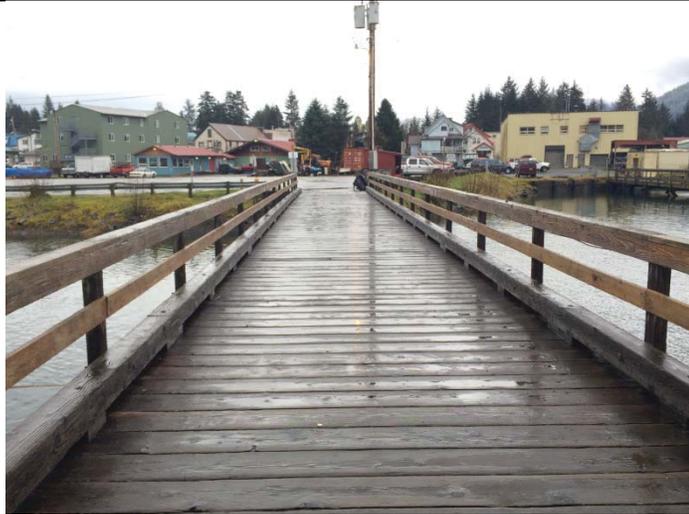
11. Approach topside

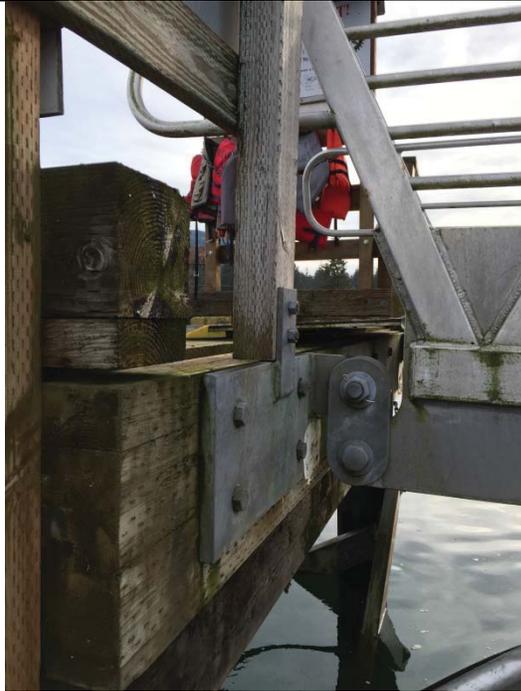
12. Gangway to Approach Connection.

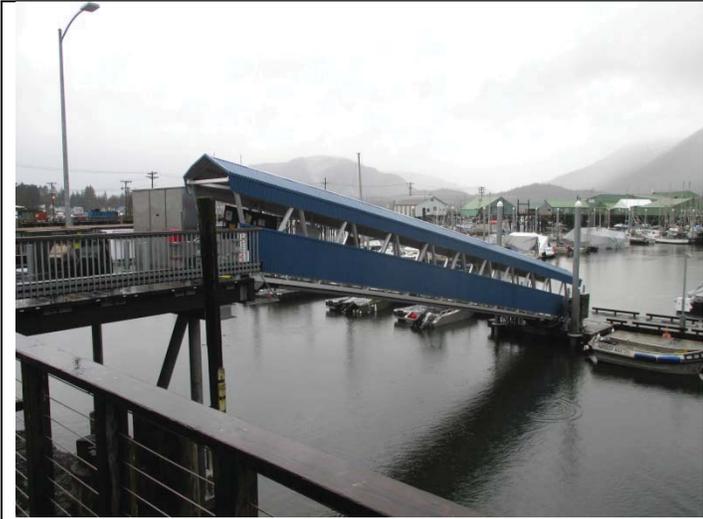
1. North Harbor Approach / Gangway

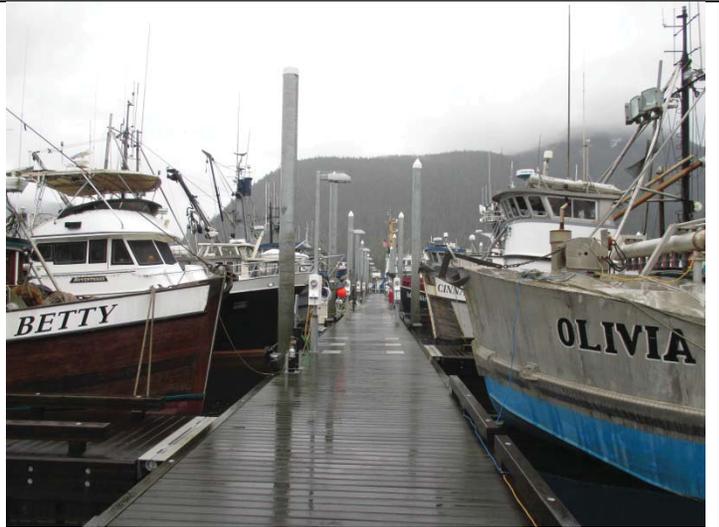
2. Typical North Harbor Float

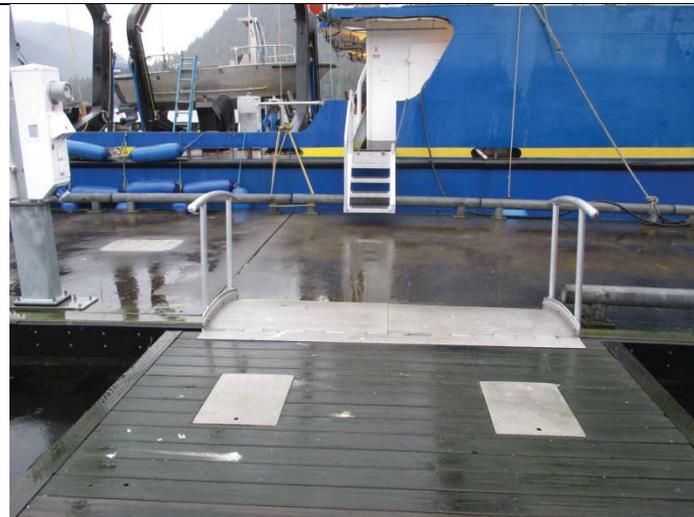
3. Transition to ADF&G Kestrel Float

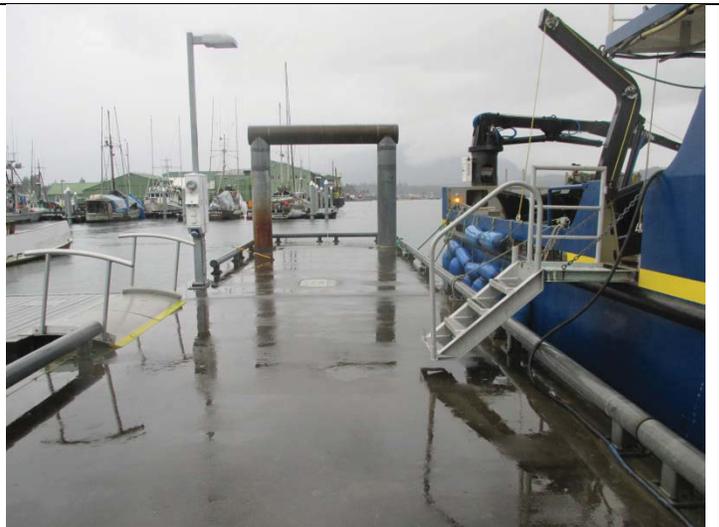
4. Typical ADF&G Kestrel Float.

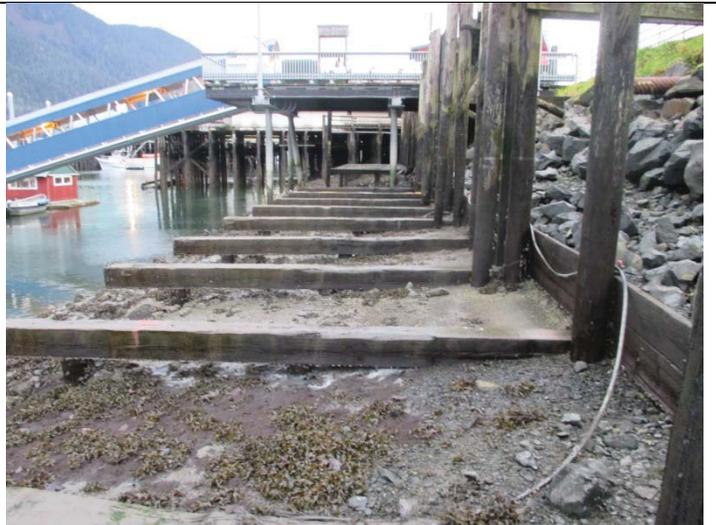
6. Grid, South of Approach, Looking North

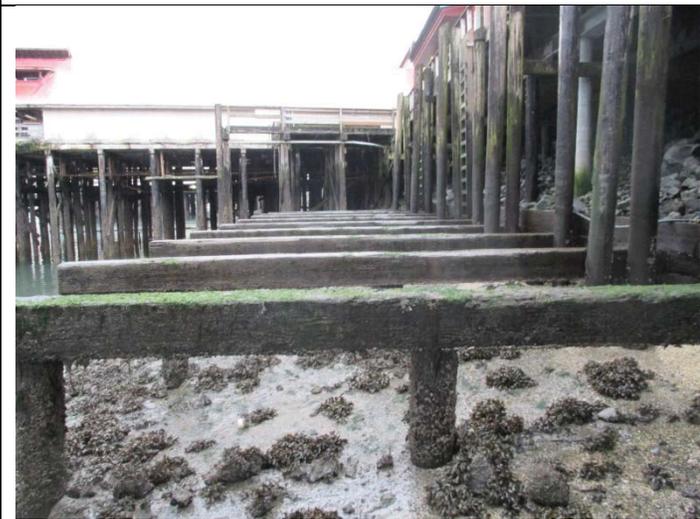
7. Grid, North of Approach, Looking North

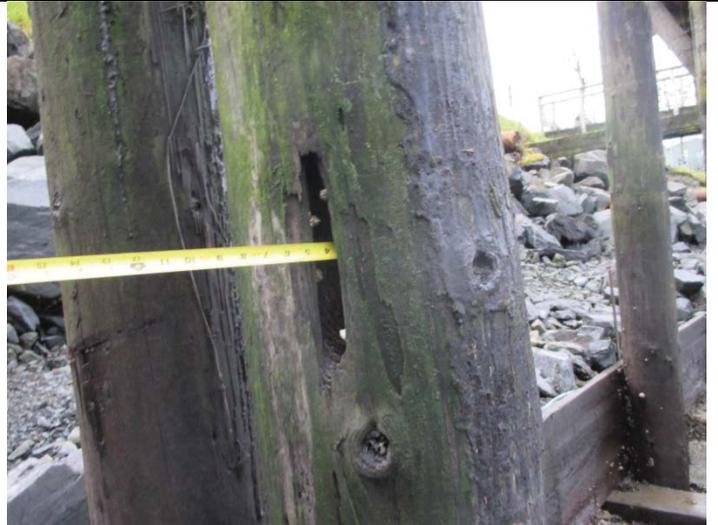
10. Hollow Fender Pile

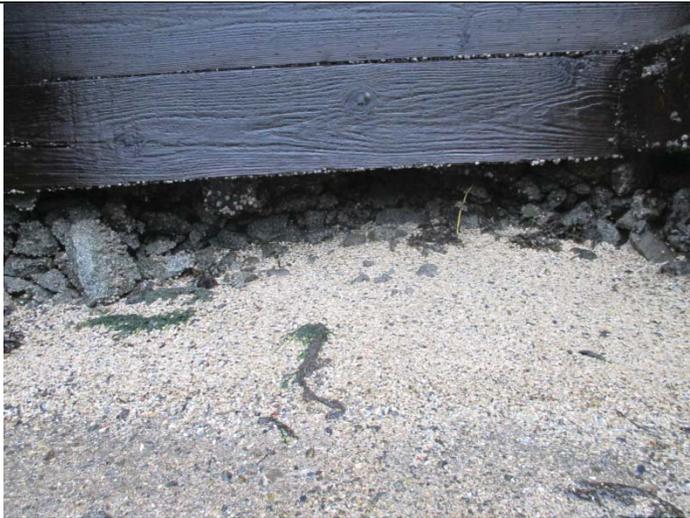
11. Undermining Retaining Wall, North of Approach.

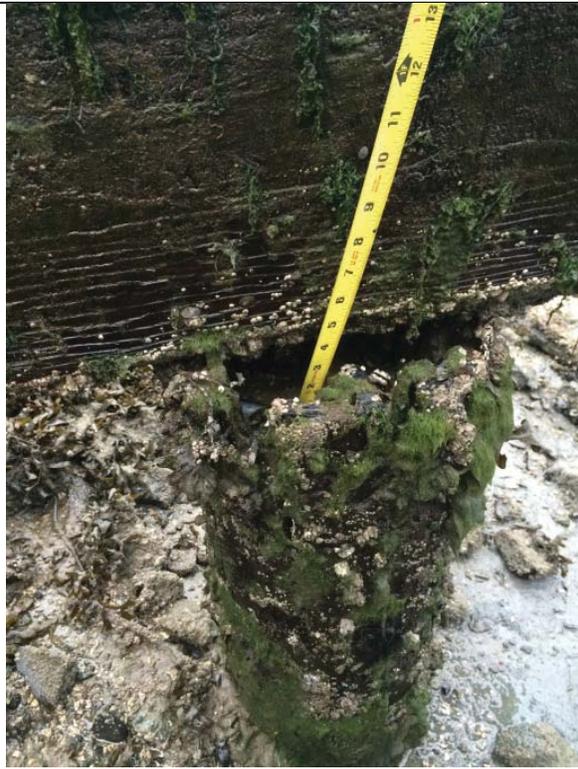
14. Hollow Grid Bearing Pile

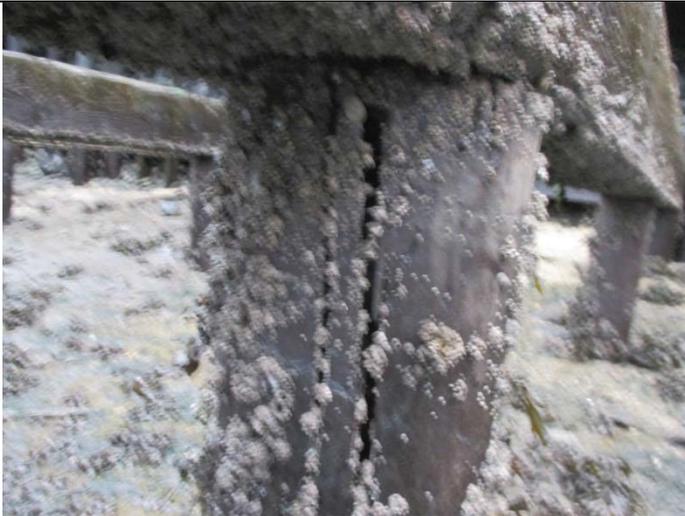
15. Hollow Grid Bearing Pile.

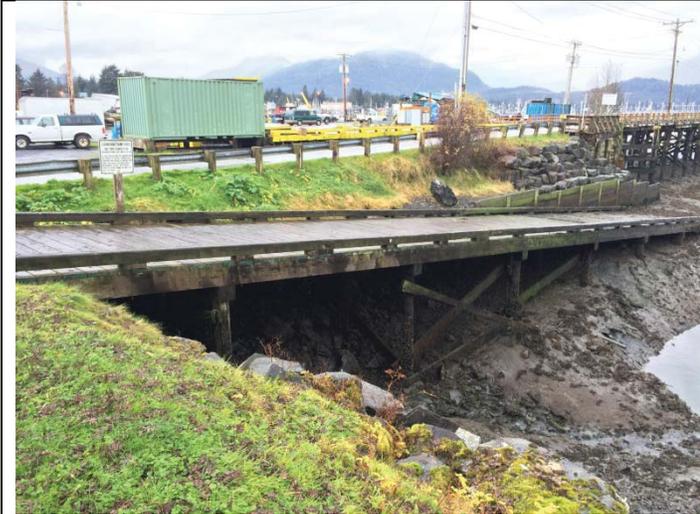
17. Timber Launch Ramp

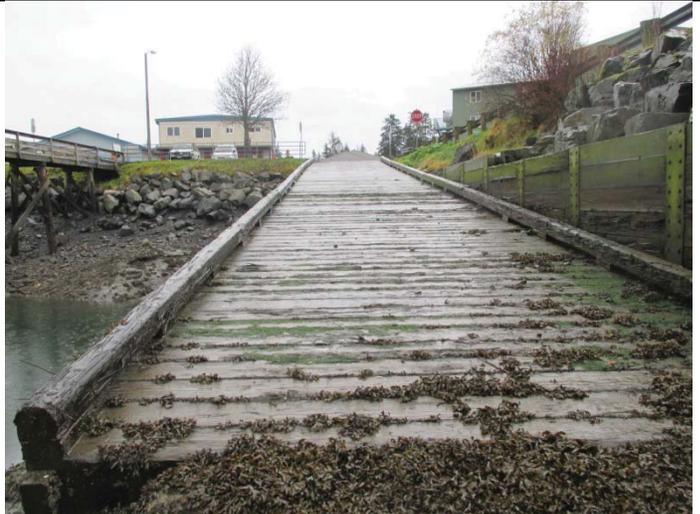
18. Timber Launch Ramp From the Bottom

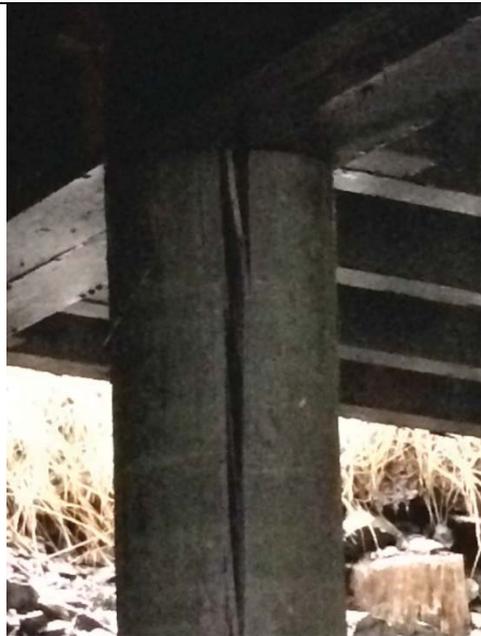
19. Split Launch Ramp Bearing Pile.
