Petersburg Borough

Harbor Facilities

Condition Assessment Report

Presented to:
Borough of Petersburg
November 24, 2015

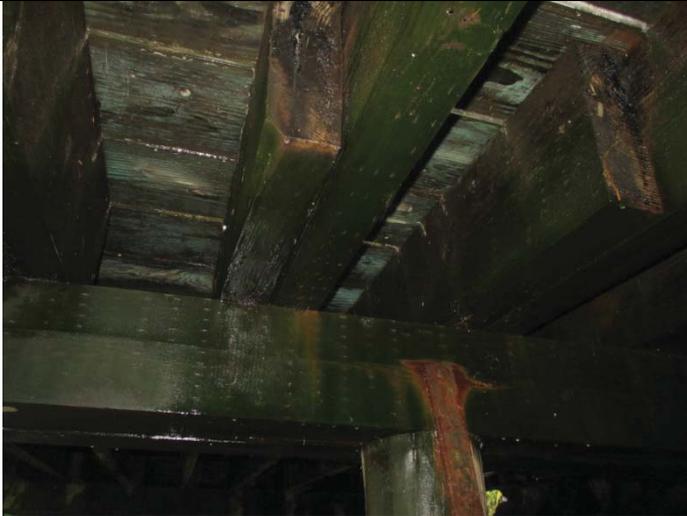
21. Typical Launch Ramp Framing

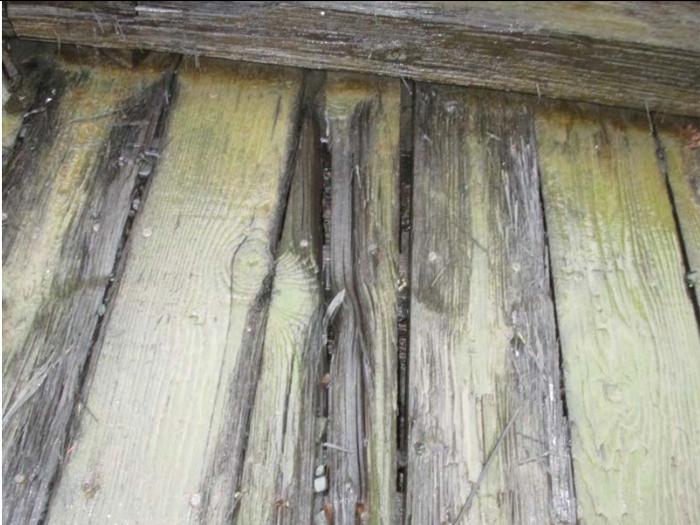
22. Split / Rotted Launch Ramp Decking

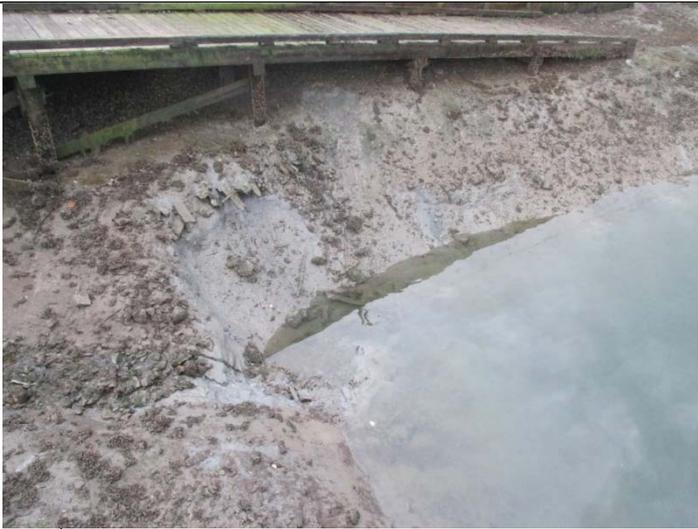
25. Erosion Between Launch Ramp and Skiff Float.

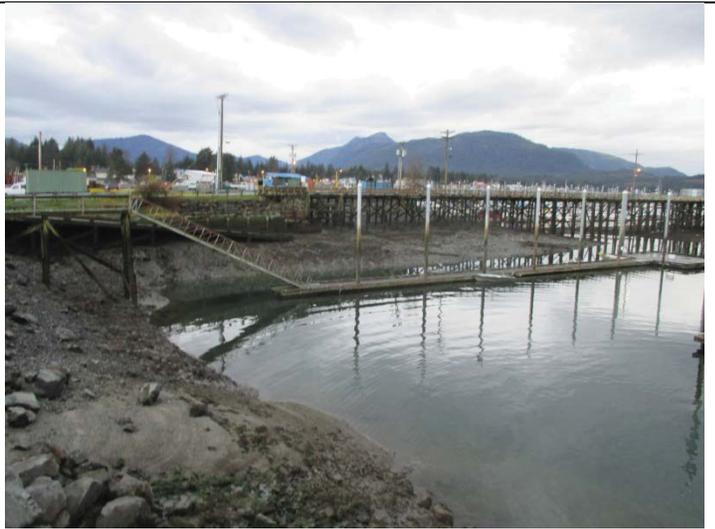
26. Skiff Float at a Low Tide.

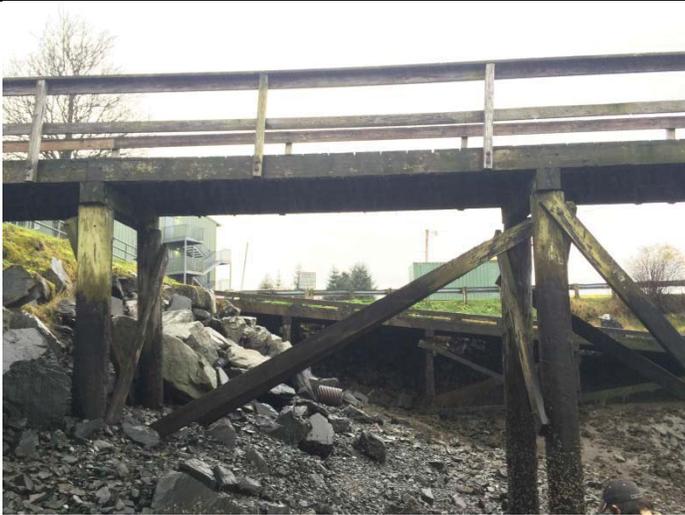
27. Skiff Float Approach.

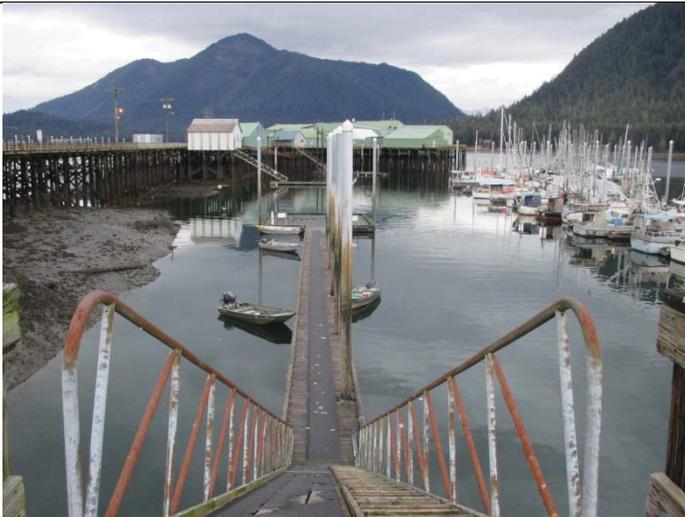
29. Skiff Float , Steep Gangway

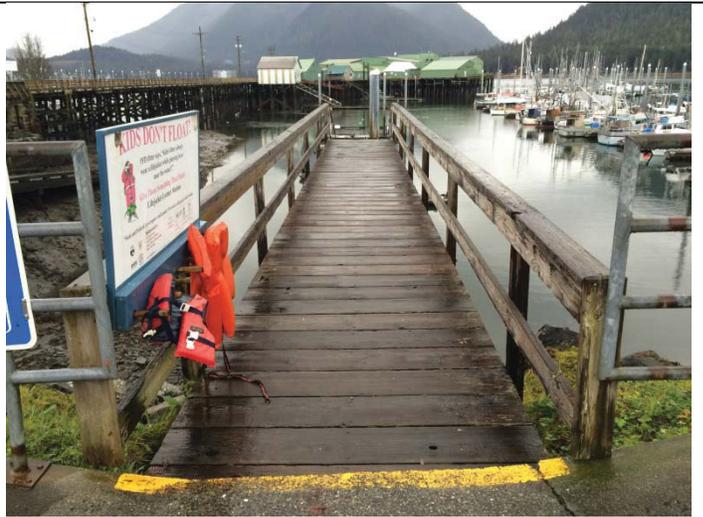
30. Skiff Float Approach

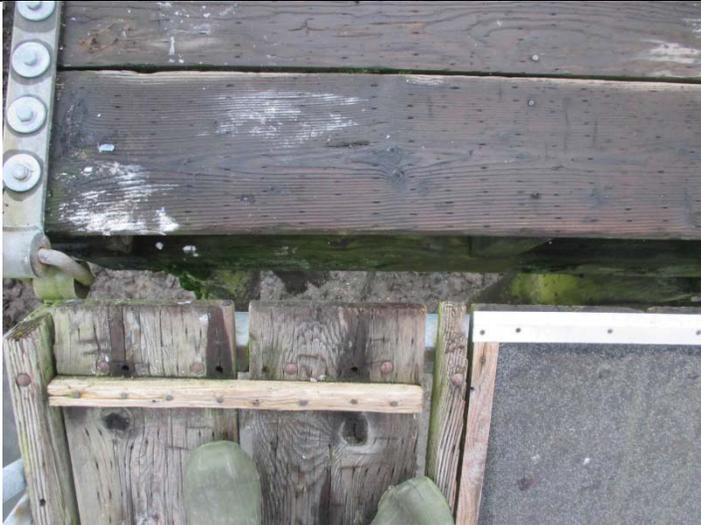
31. Gap at top of Gangway at Skiff Float.

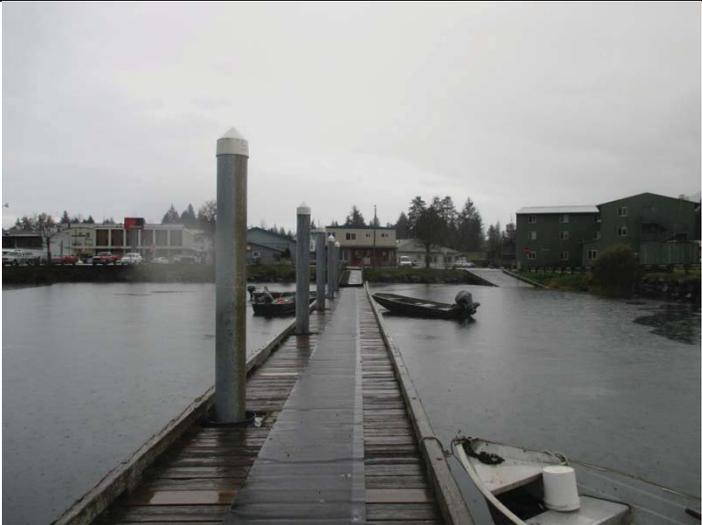
32. Typical Skiff Float Looking Towards Shore

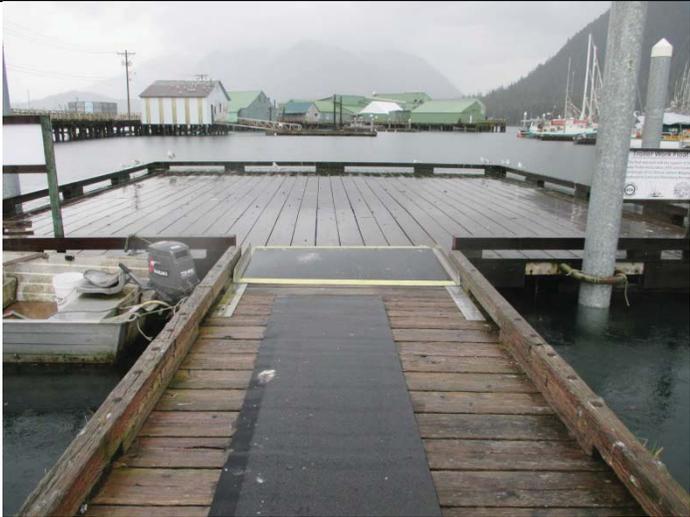
33. Transition from Skiff Float to Troller Float

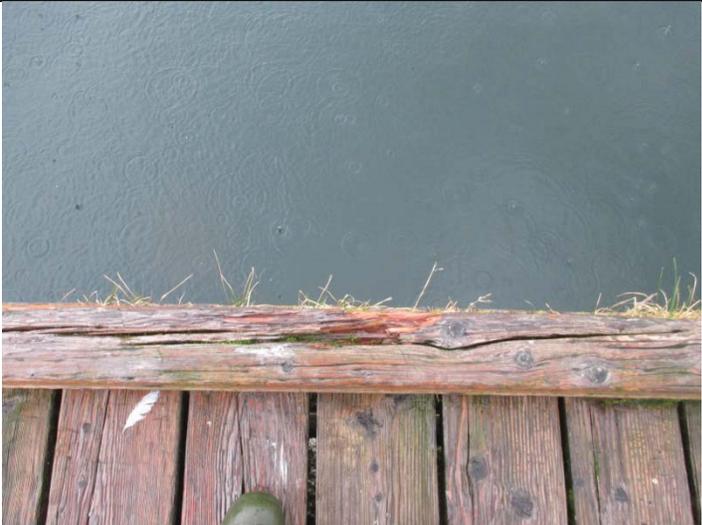
34. Rotted and Split Timber Bullrail

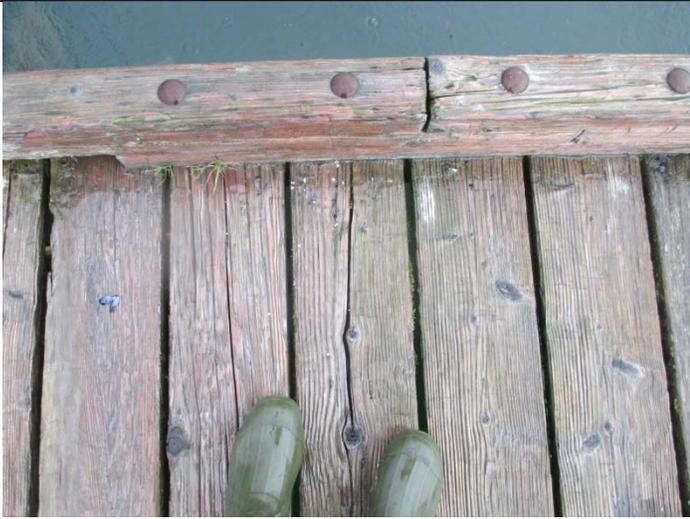
35. Split Decking on Skiff Float.

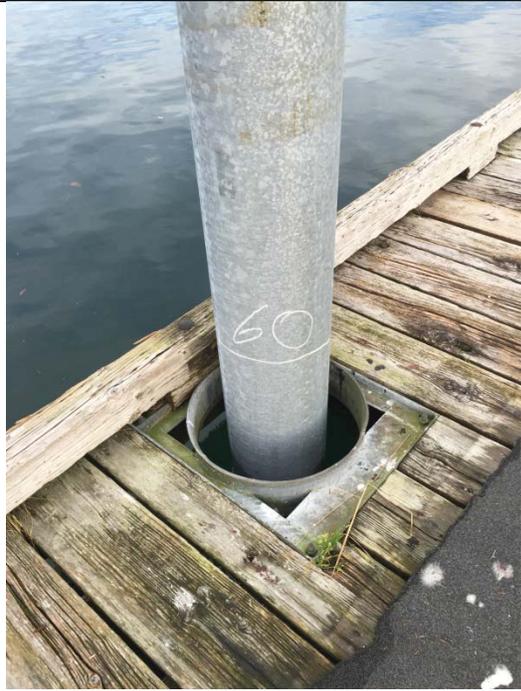
36. Steel Pipe Pile at Skiff Float

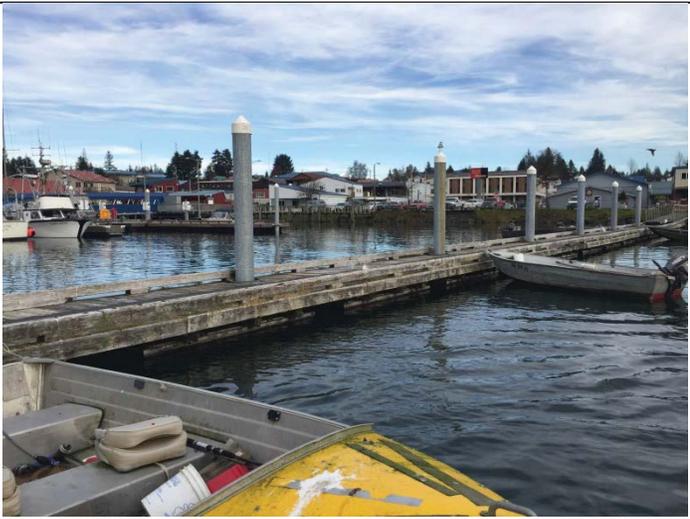
37. Skiff Float viewed from Troller Float

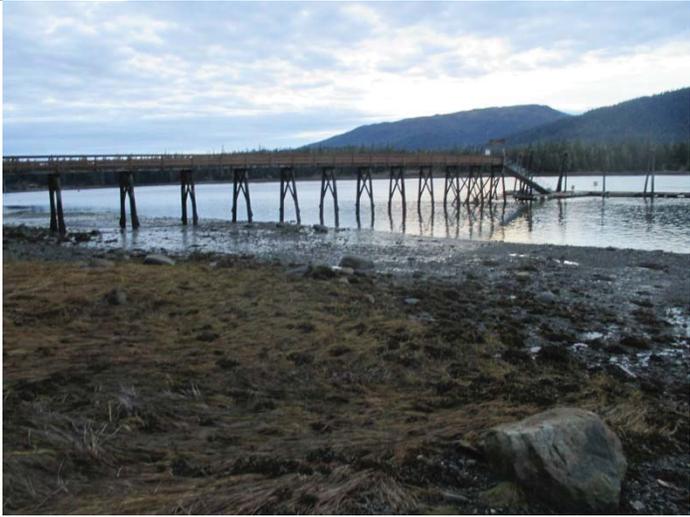
1. Papke's Landing

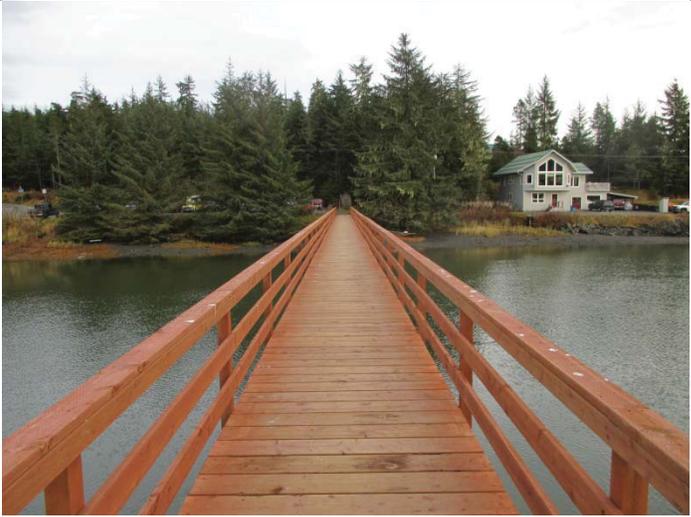
2. Papke's Approach, Topside

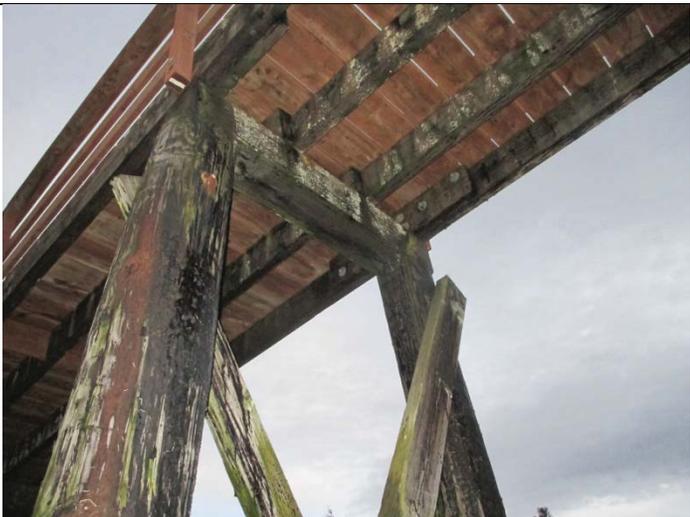
3. Papke's Approach, Typical Framing

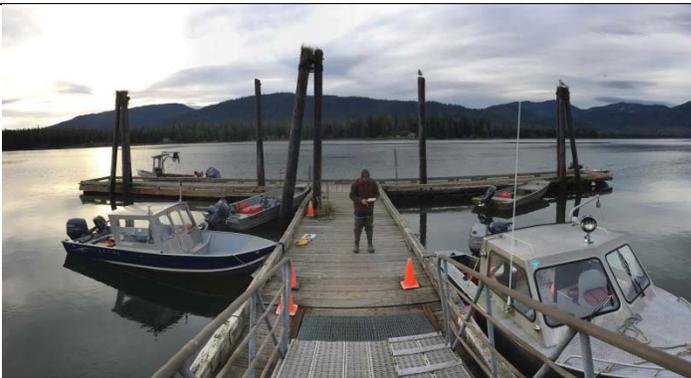
4. Papke's Float

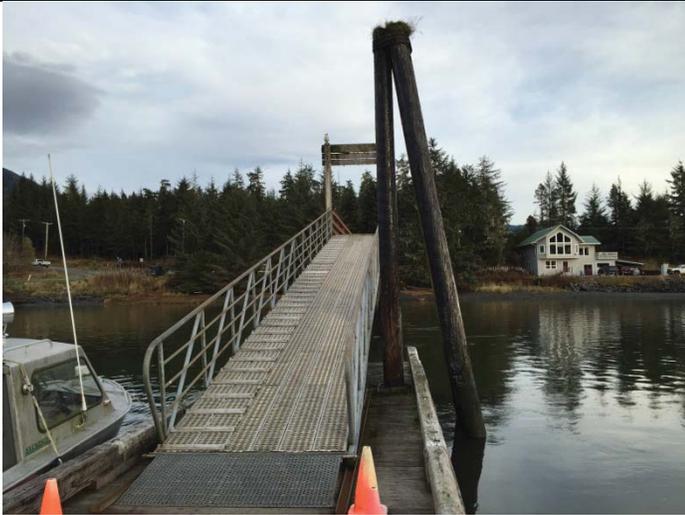
5. Papke's Gangway

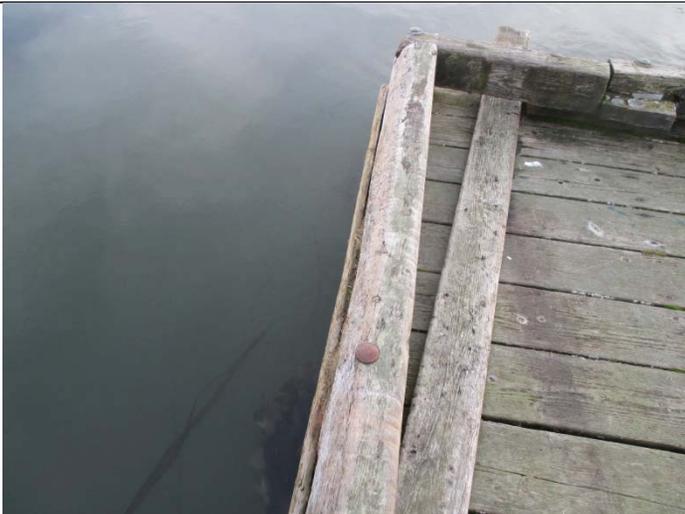
7. Papke's Worn, Broken Bullrail

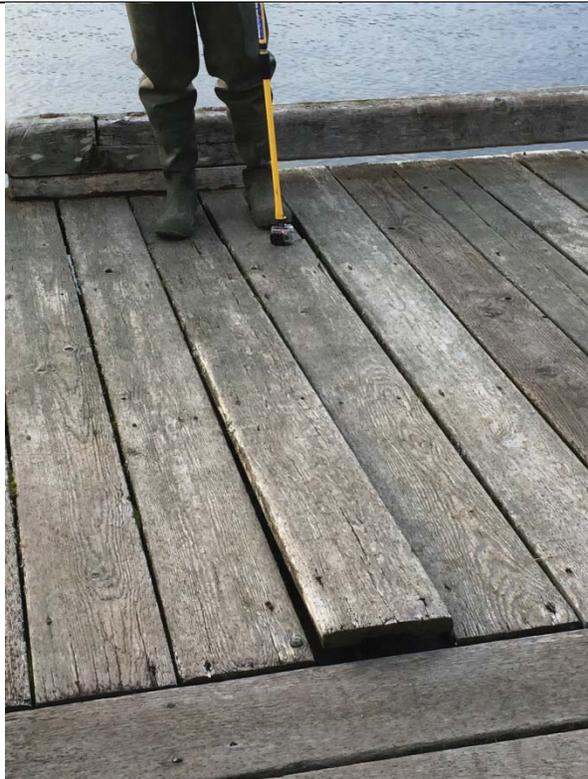
8. Papke's Float Decking

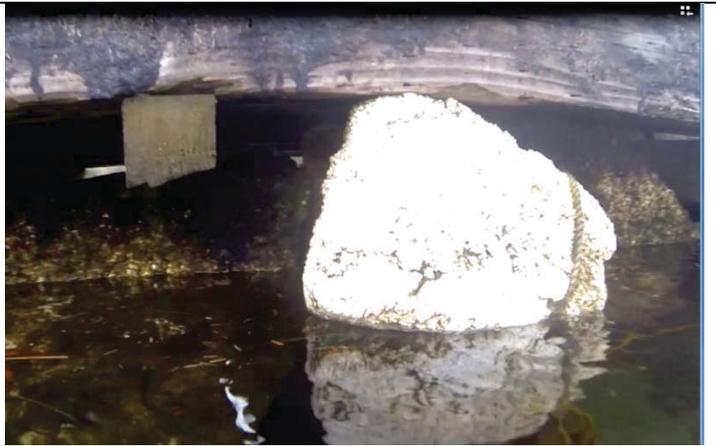
10. Damage to Flotation and Sill

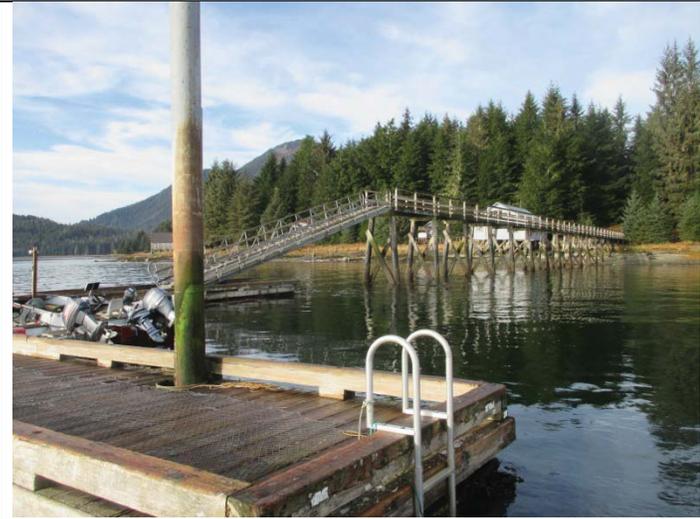
1. Kupreanof Float and Approach

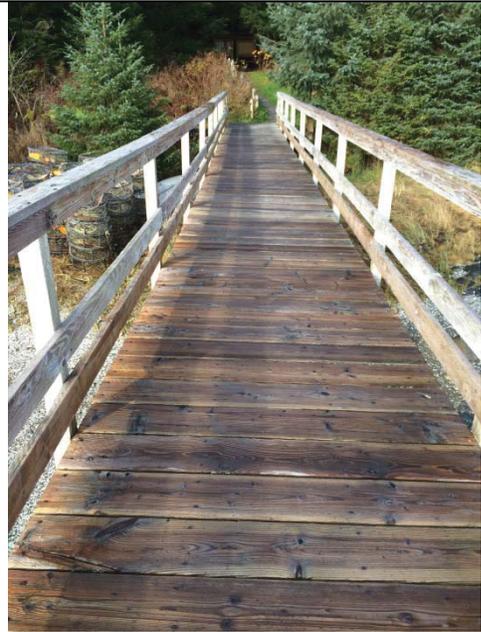
2. Approach Top Side

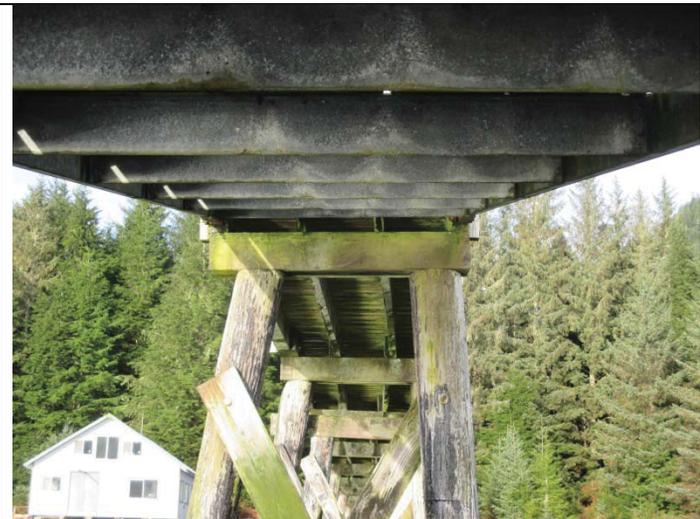
The stringers and pile caps appear to be in mostly good shape (Photo 3). Some of the pile caps have vertical cracks up to ¼" wide through their centers (Photo 6). The stringers are largely protected from the elements and appear to be in good condition. The 3rd pile bent from shore is leaning at approximately 10 degrees from vertical, towards the water.

3. Approach Framing

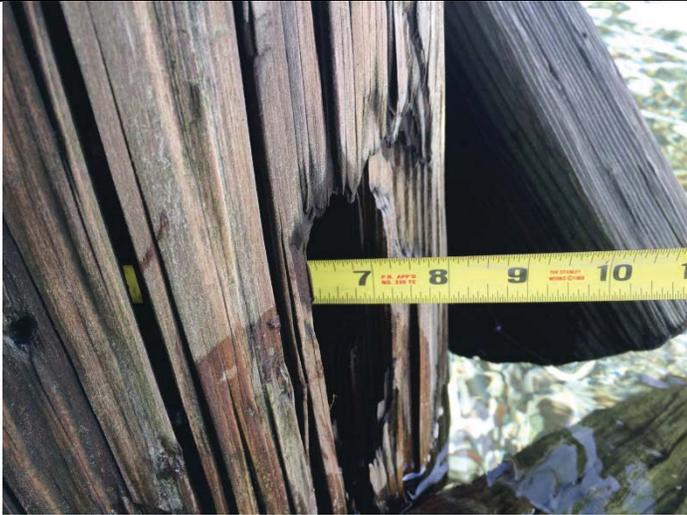
The timber bearing piles appear to be in good condition at first, however multiple piles were found to have hollow areas near the MLLW (0') water line (Photo 5). Only several of these locations were inspected in detail due to tide levels. In 2 cases, over 50% of the cross section was void. A 2011 Underwater inspection report, commissioned by the State of Alaska, found 12 of the approach piles to have large splits, hollow areas, or softness in the intertidal zone. The above referenced underwater inspection report was prepared for ADOT&PF Bridge Section, Project # 80803/BR-NBIS(65) & 80801/BR-NBIS(64)

5. Hollow Approach Bearing Pile

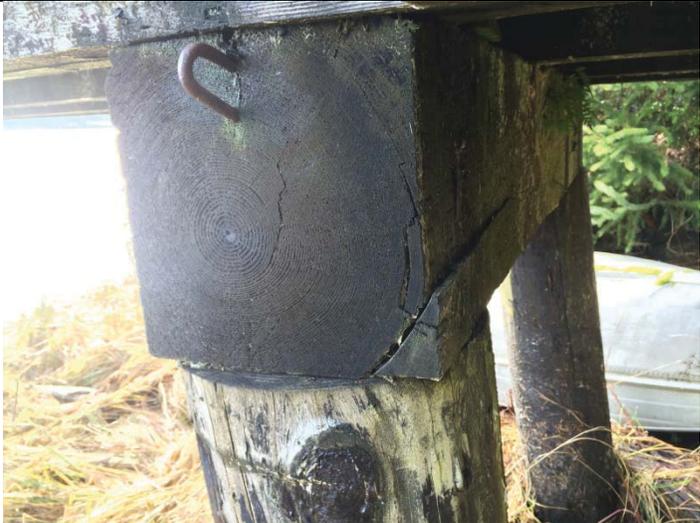
6. Cracked Pile Cap

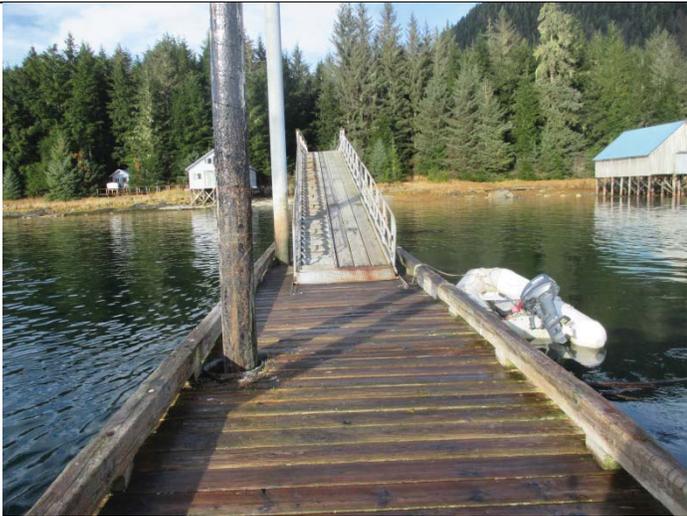
7. Float and Gangway

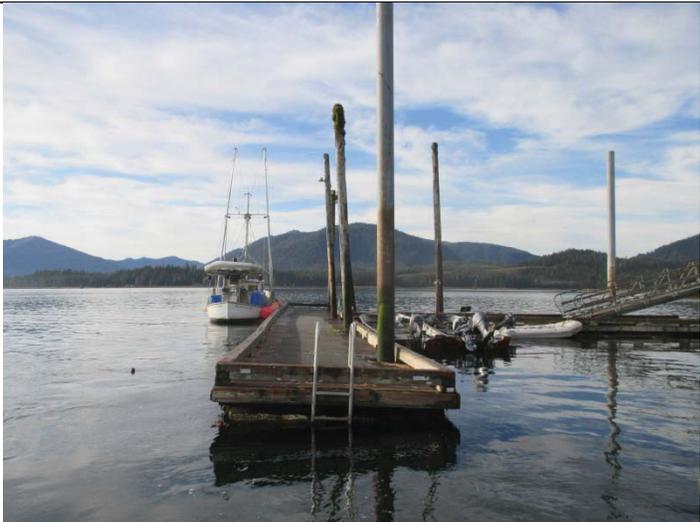
8. Listing Float, note crooked pile

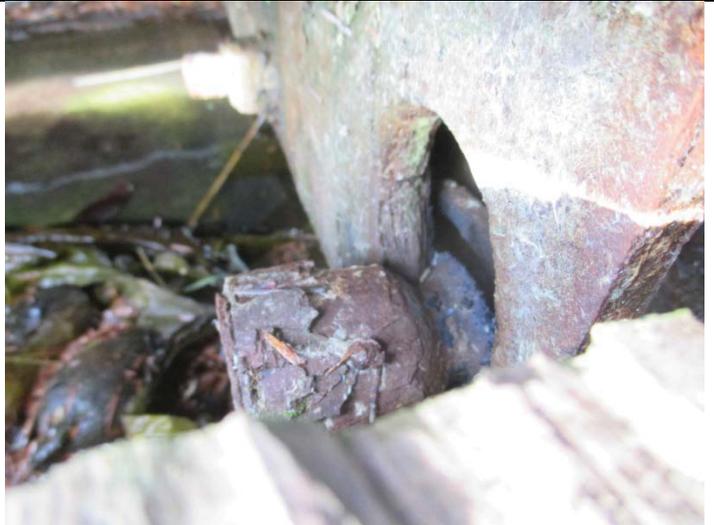
10. Worn and Corroded hinge components

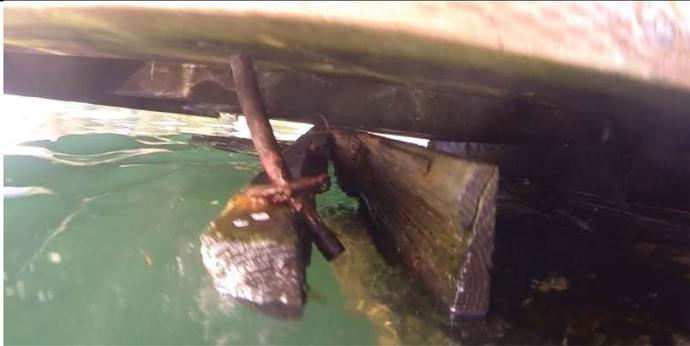
11. Broken Sill, Note missing flotation
